USAF Cape Canaveral Station, Florida

US Army Sea Side Corrosion Test Site

Report issued by MMI, Dick Yesensky, Nov.21st 2003

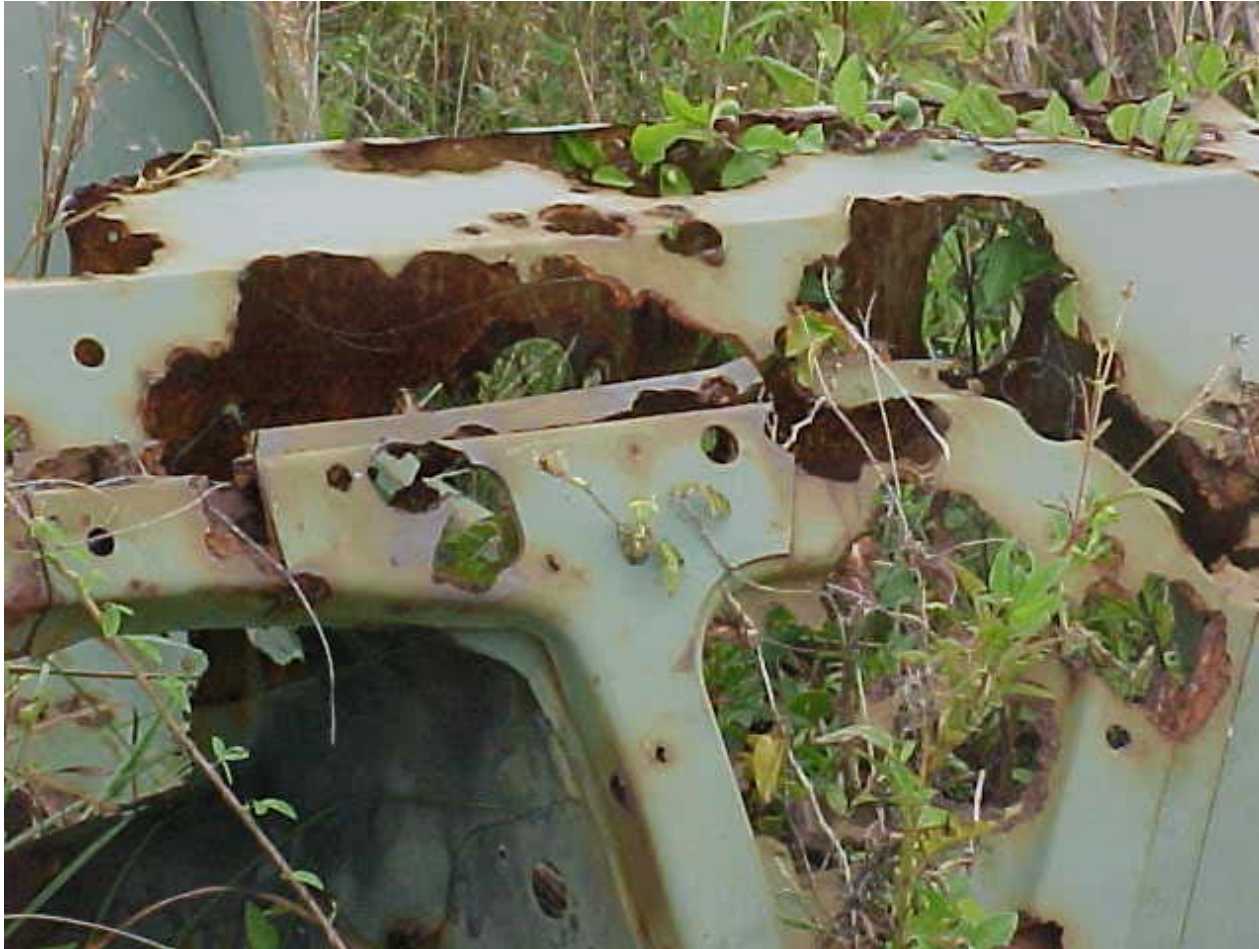
Army trucks after 3 years of exposure using typical epoxy paints. 3 years of sea side exposure shows massive corrosion and complete loss of steel panels and structures

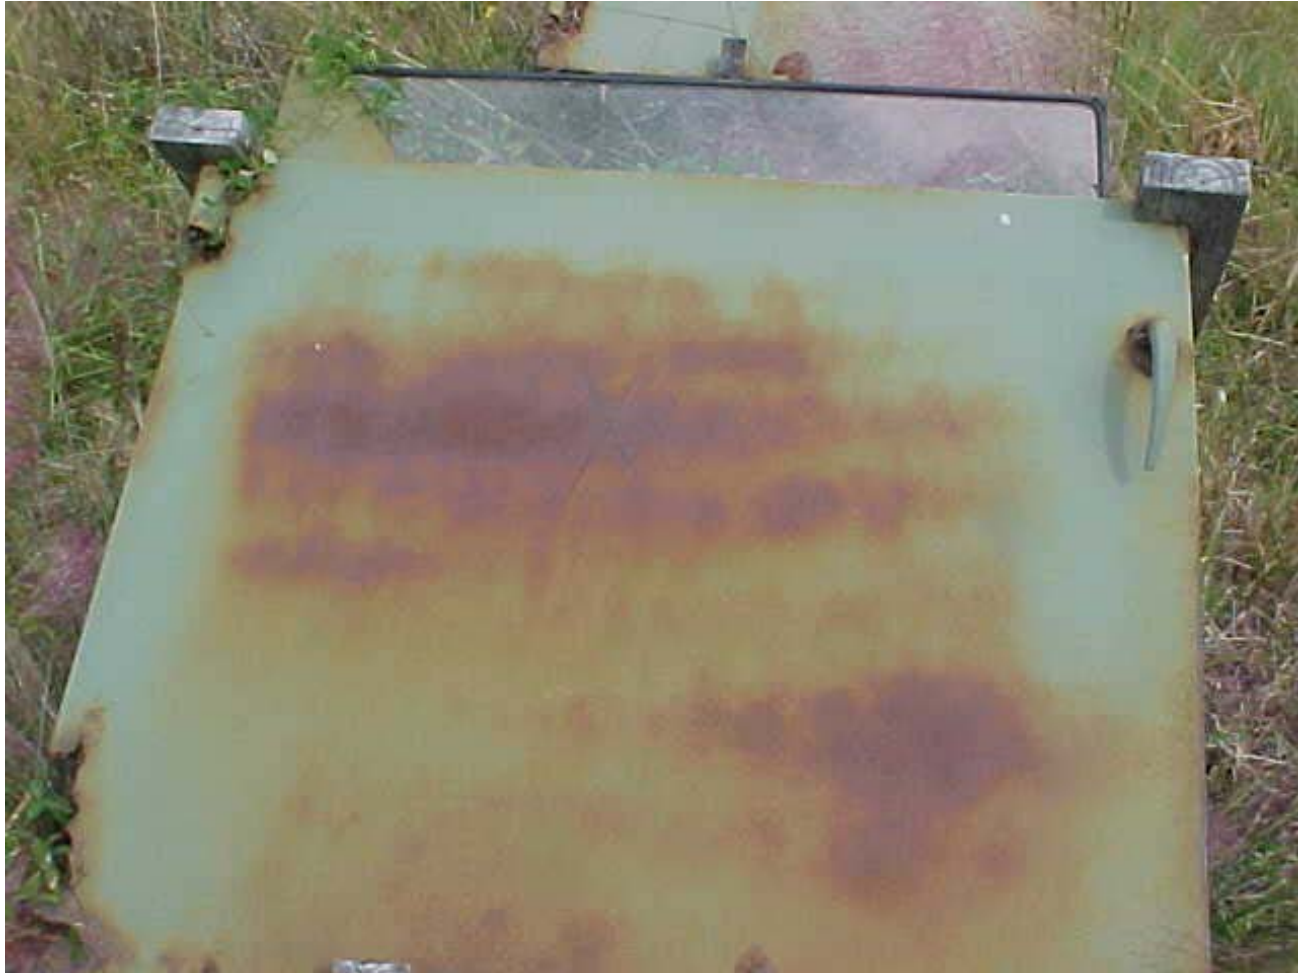
Control Door – typical epoxy paint used on truck door – 3 years of exposure in the sea side tests done by US Army

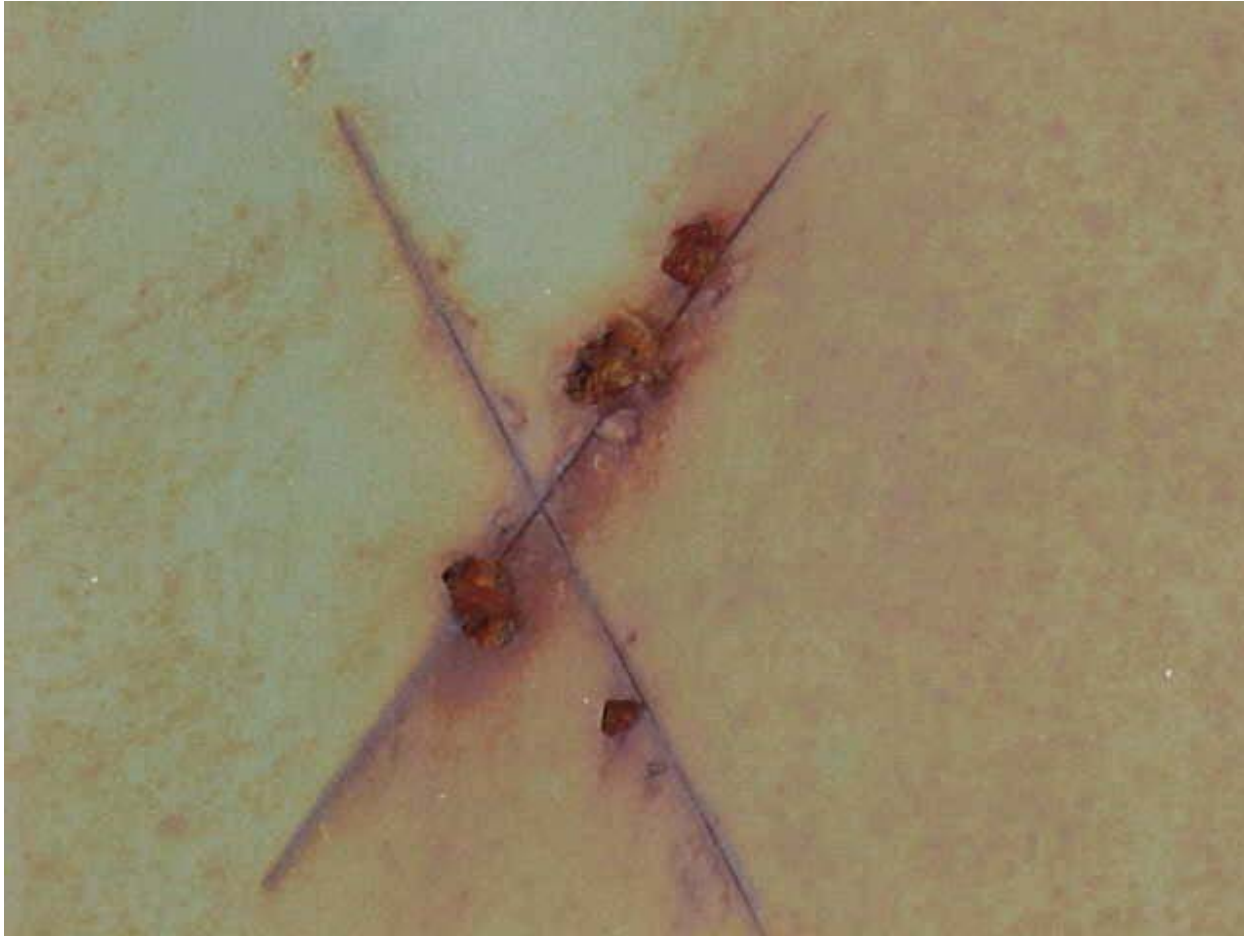
Control Door (epoxy paint)– Close up of “cut” shows deep pitting and the beginning of holes in the steel control door – this is the result of 3 years at the US Army sea side test site.

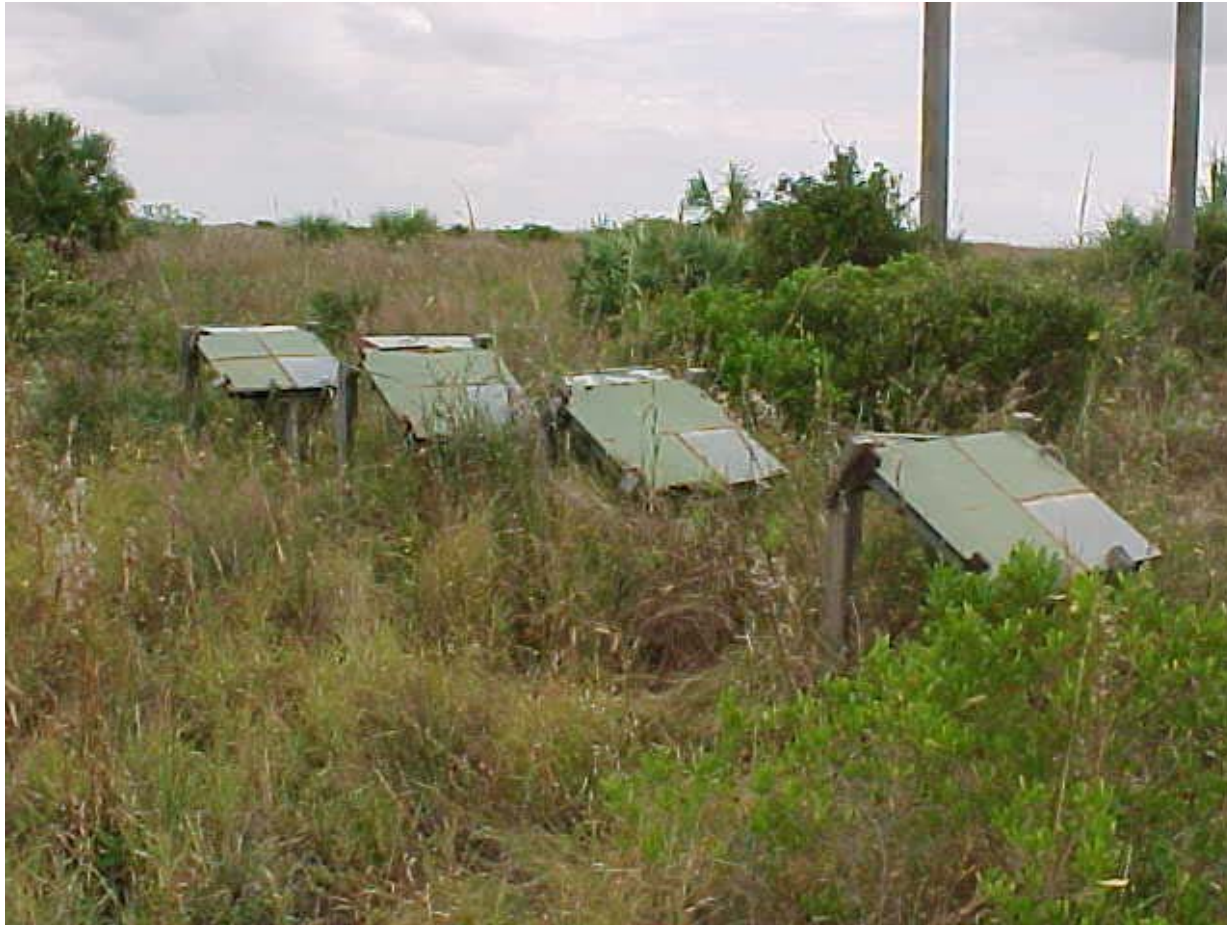
Quad Tests – Doors were divided into quadrants for a test of coatings and primers. Each quadrant was used for primer only; top coat only; & primer and top coats

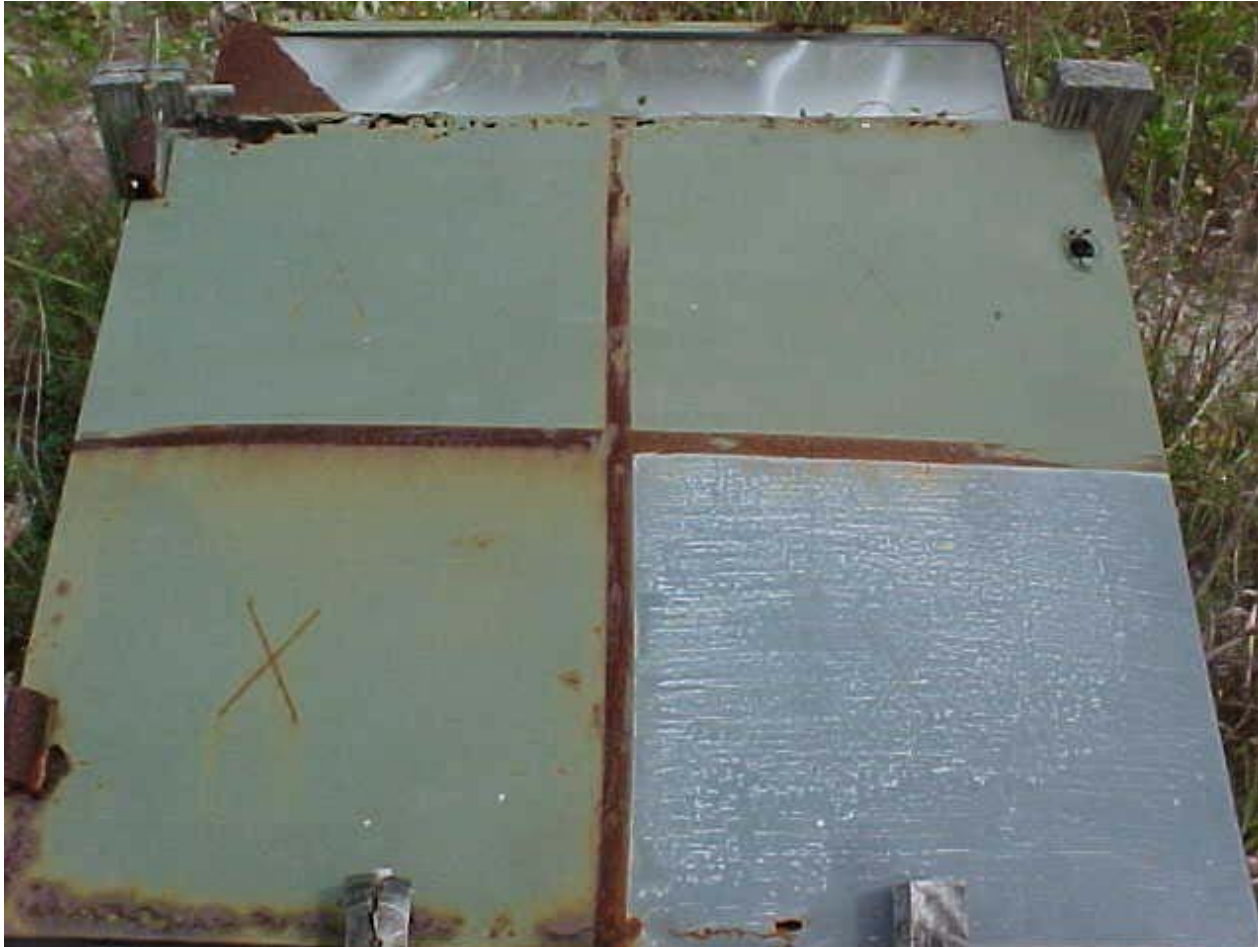
Quad Tests- The Army Truck Door is divided into Quads- Lower Right Quadrant is ZINGA ALONE (PRIMER ALONE); Upper Right Quadrant is ZINGA With CARC top coating. Lower Left Quad is NO ZINGA, only top coat; Upper Left Quad is ZINGA with top coat and CARC: KEY Results: ZINGA ONLY shows NO RUST; the Quad w/o ZINGA shows rust coming thru at several places, showing major rust after 3 years.

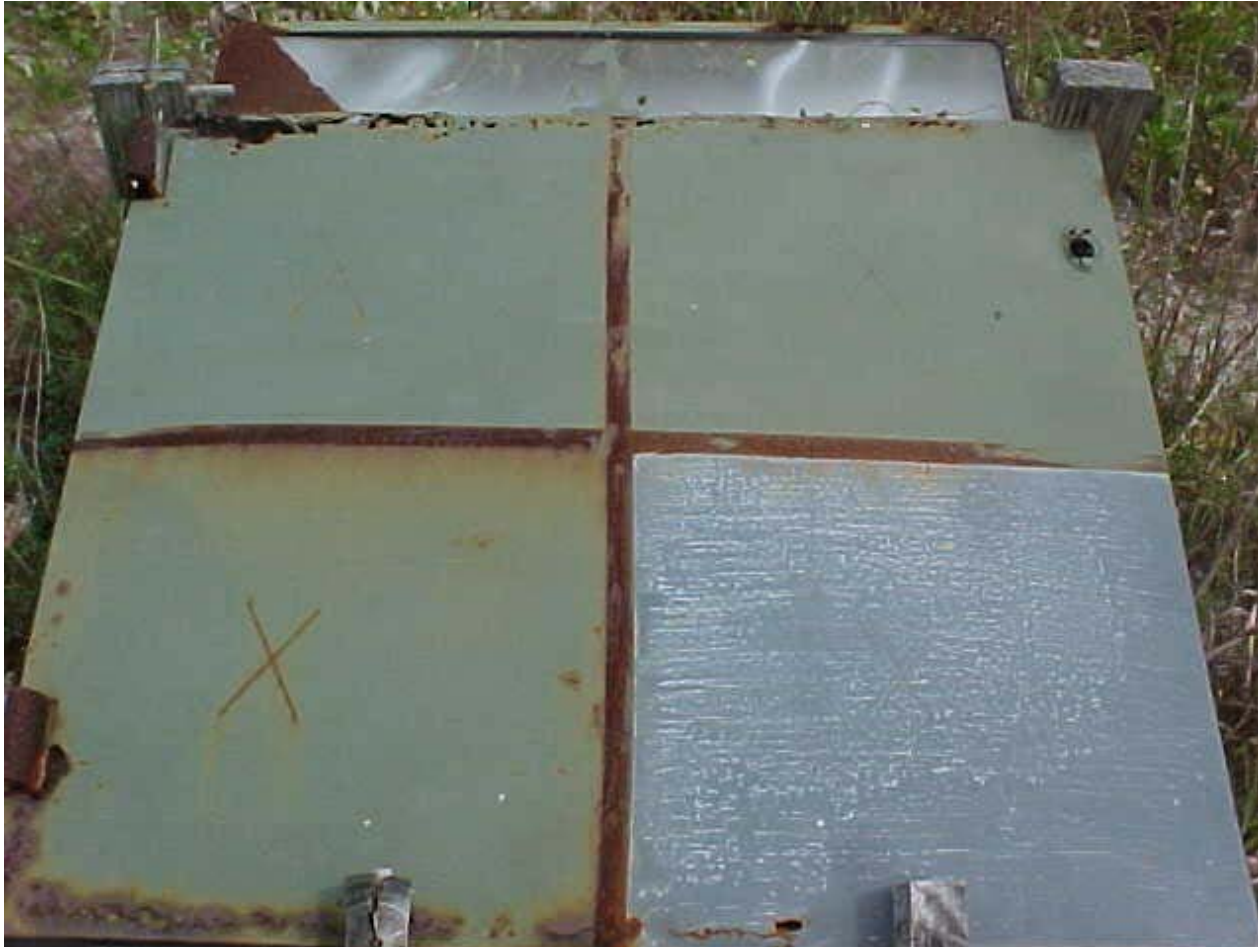
NOTICE the QUAD Dividing lines. This is where NO ZINGA or protection was Provided. Rust has caused major damage in these areas. With no protection the Rust in just 3 years has ruined this door. This door is not serviceable and will have To be replaced.

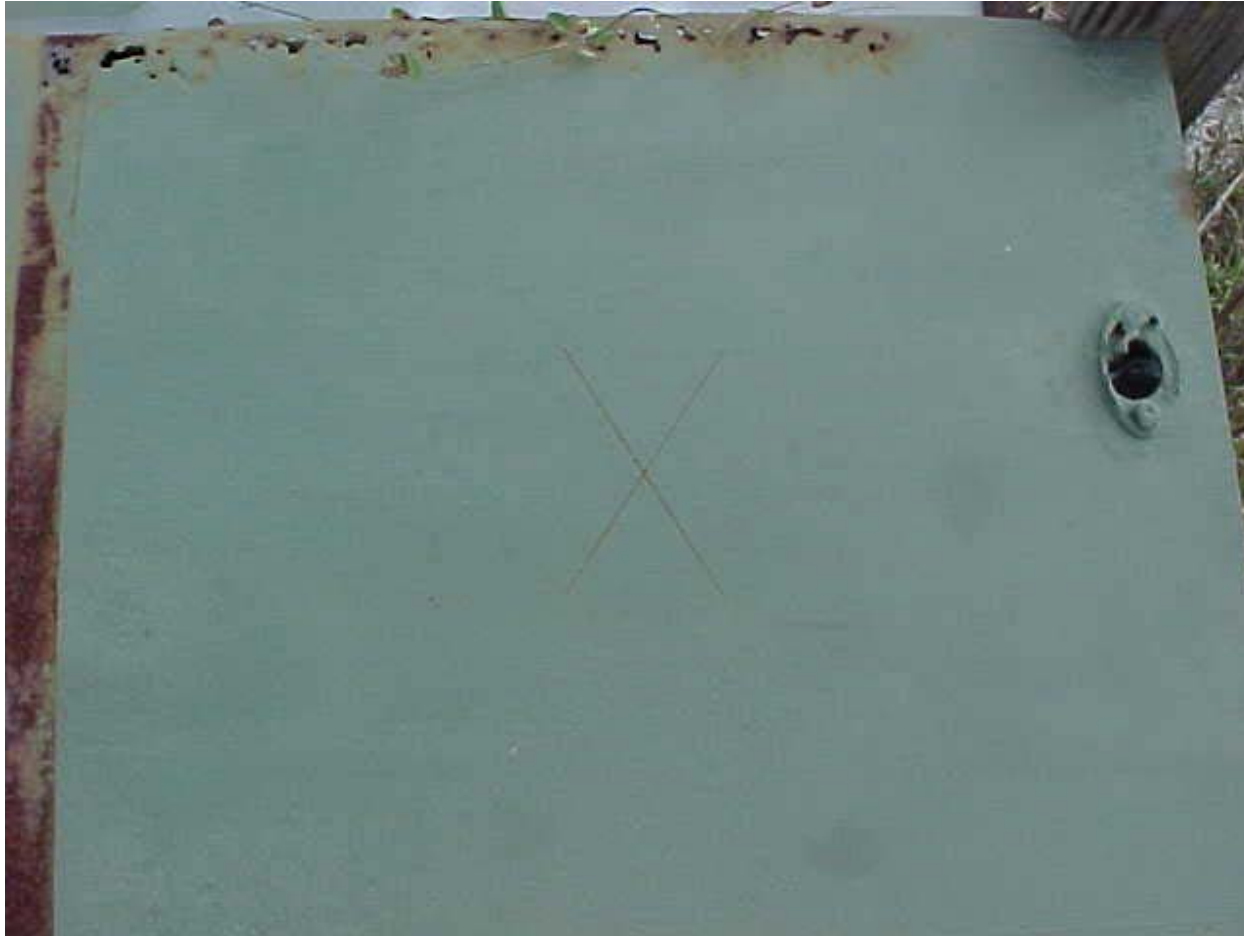
Quad Tests- This is closer picture of Upper Right Quad which is ZINGA Primer with CARC top coating- NO RUST present except Slight rusting at CUT where ZINGA is NOT present.

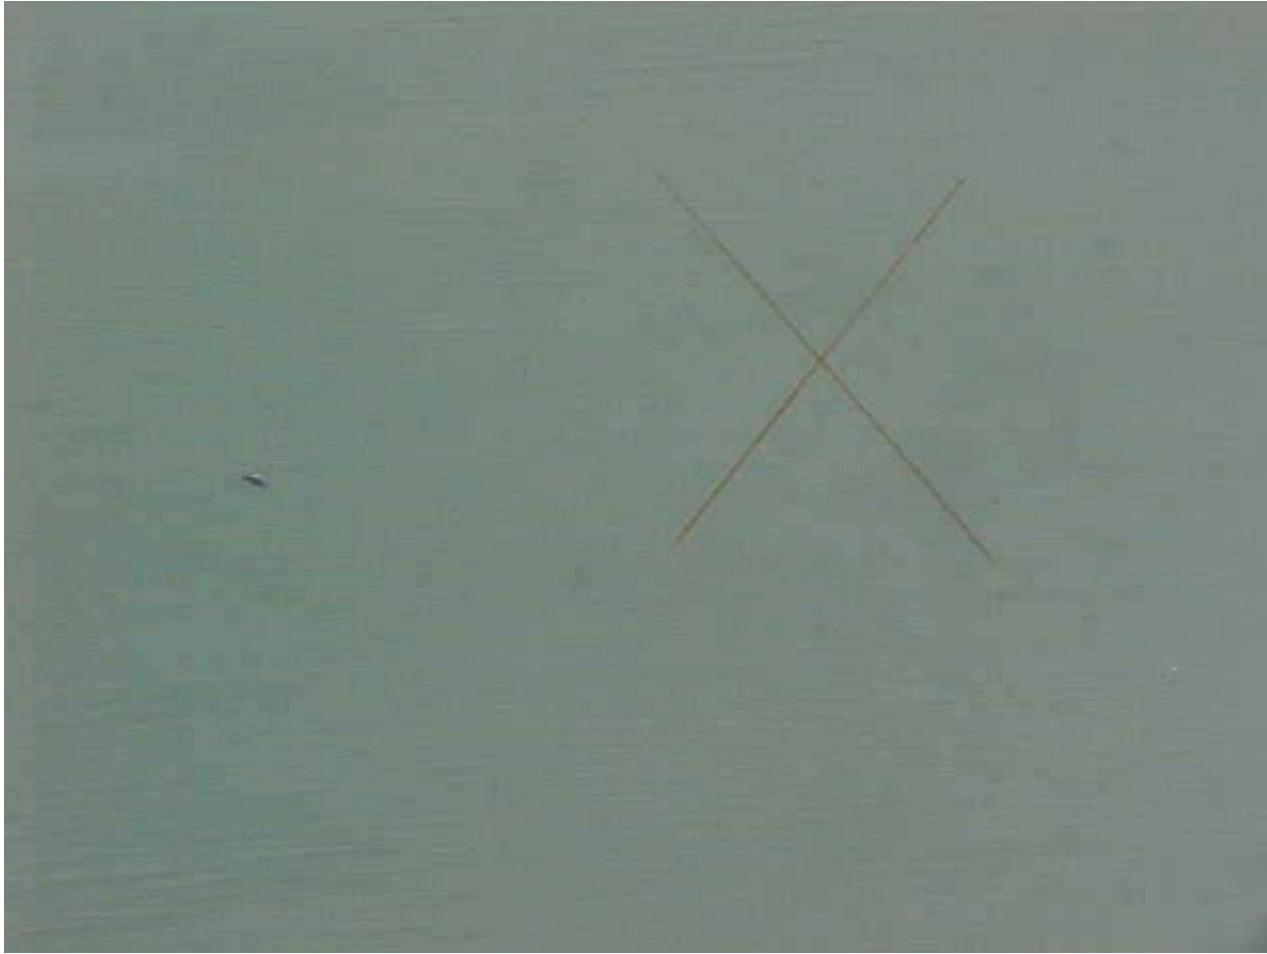
Quad Tests- This is closer picture of Upper Right Quad which is ZINGA Primer with CARC top coating- NO RUST present except Slight rusting at CUT where ZINGA has been removed by CUT

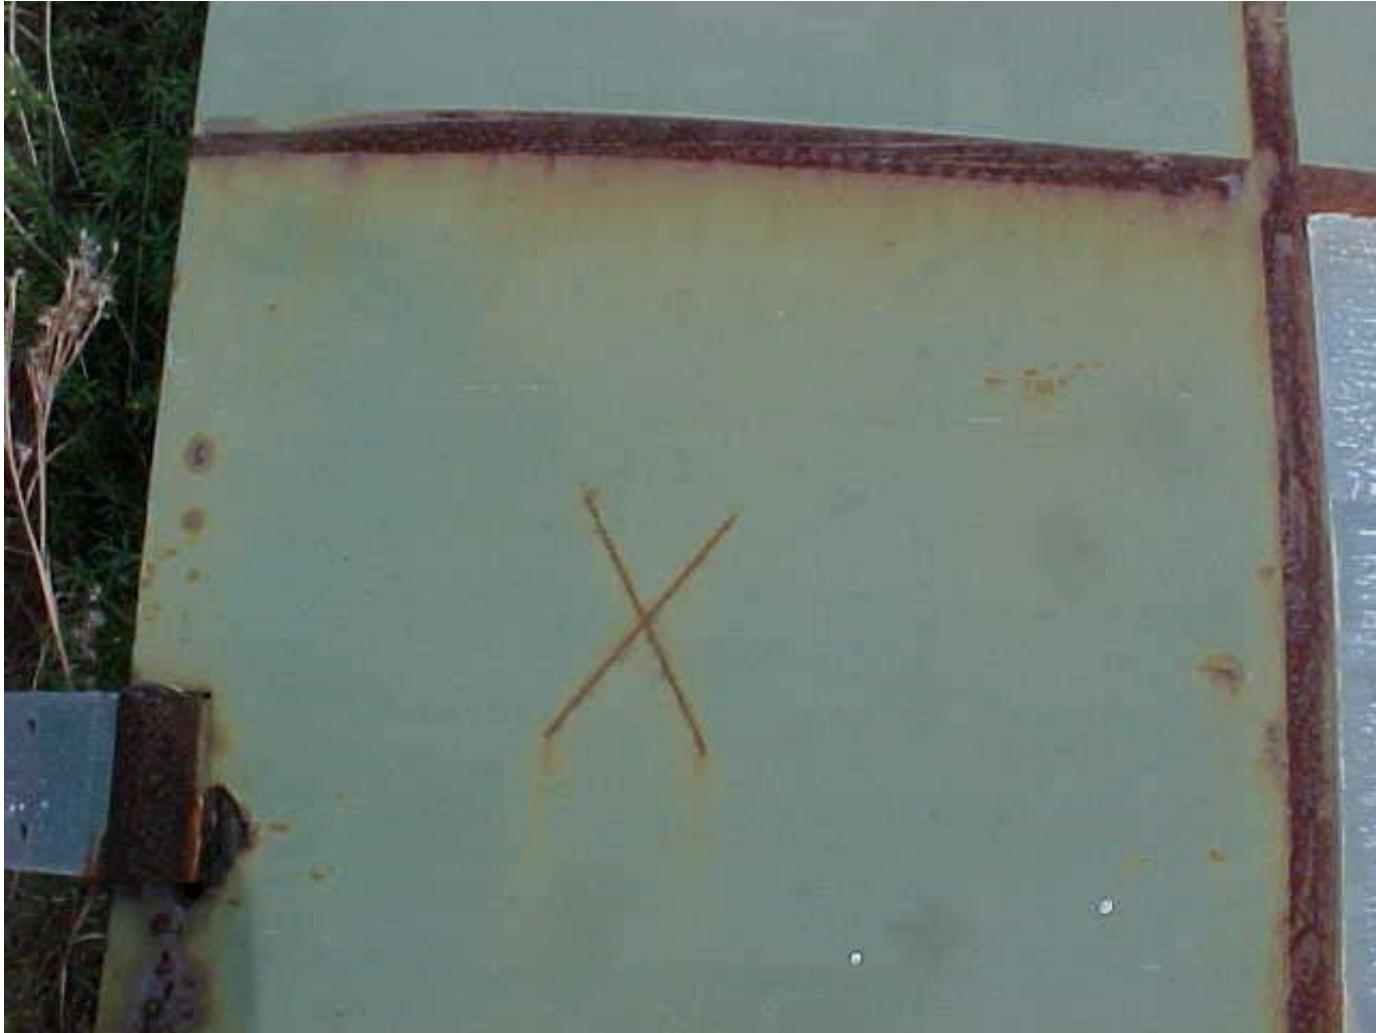
Quad Tests: This shows the LOWER LEFT Quad where NO ZINGA Has been applied – this is top coat only and after 3 years major Rust can be seen coming through all over the door.

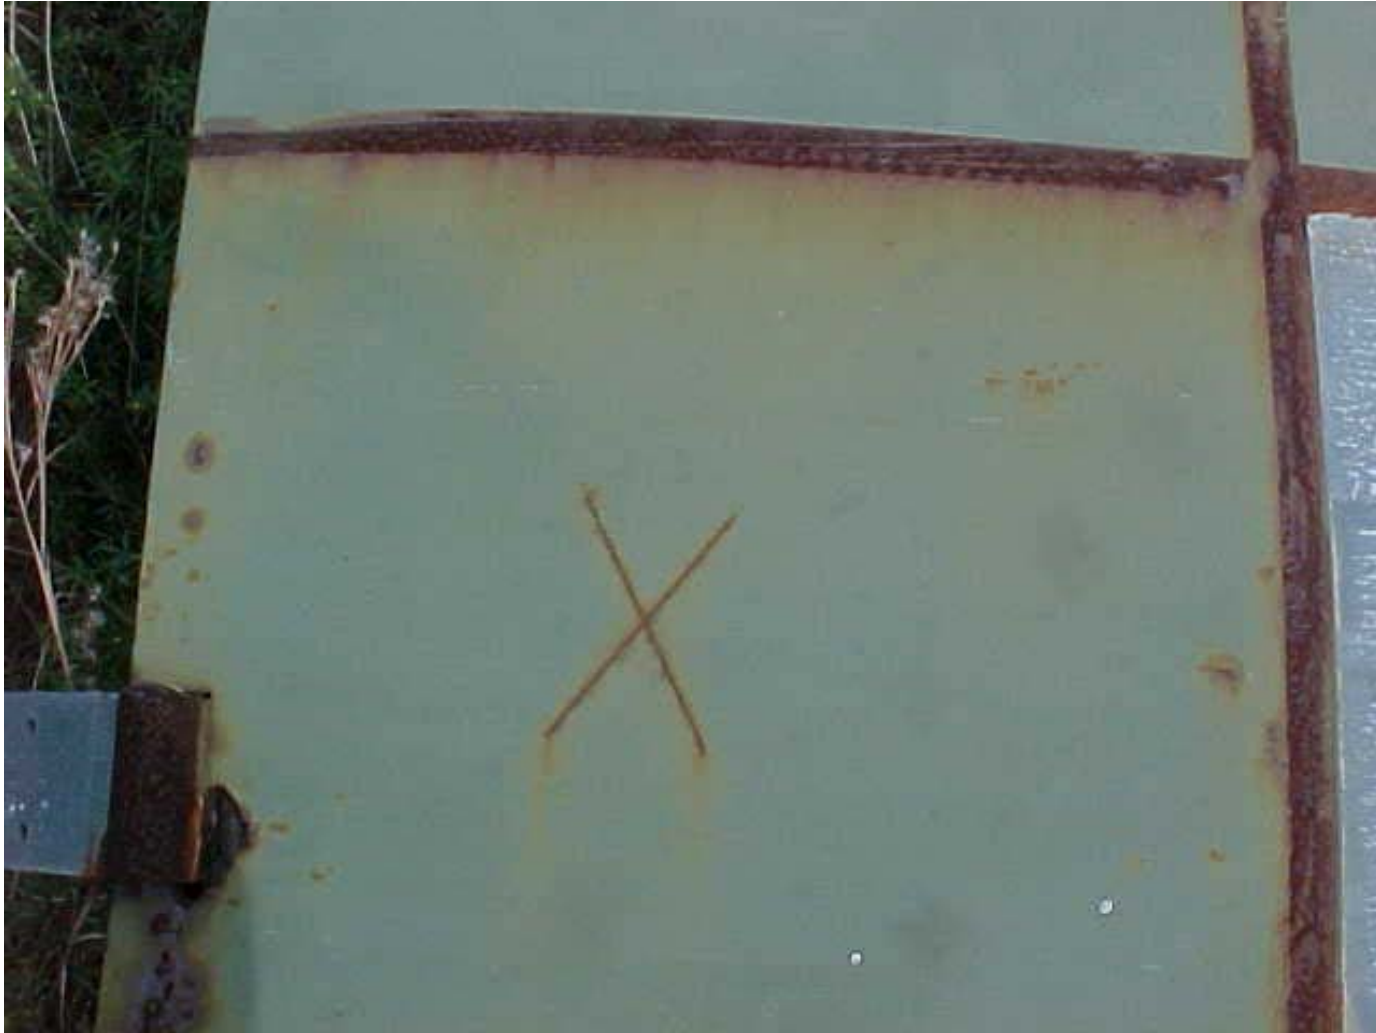
Quad Tests: This shows the LOWER LEFT Quad where NO ZINGA has been applied – this is top coat only and after 3 years major rust can be seen coming through all over the door.

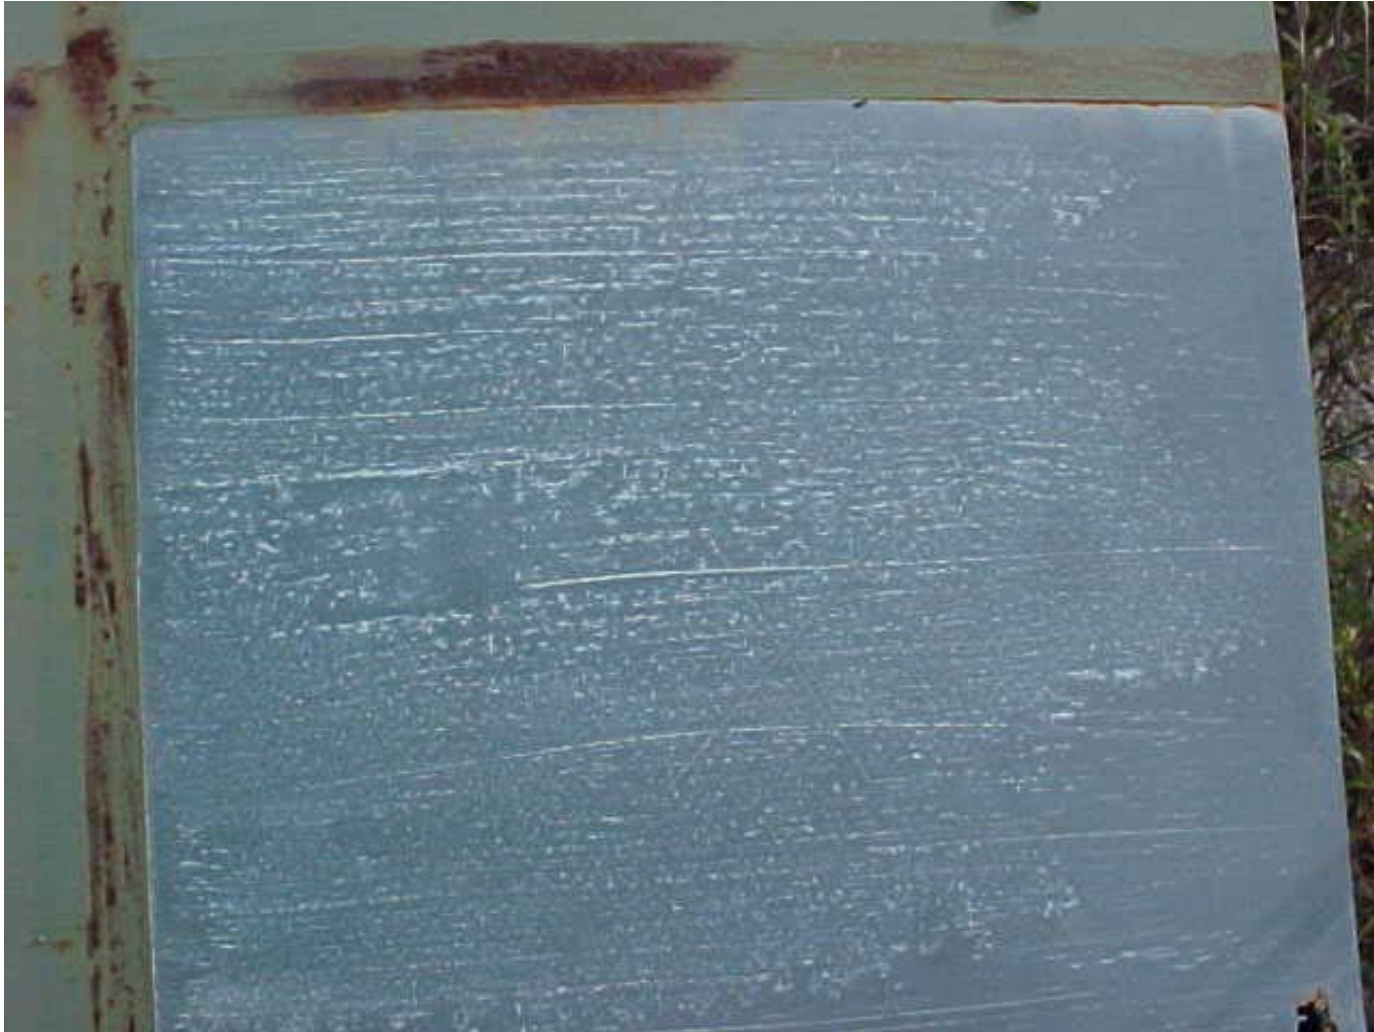
Quad Tests: This shows the Lower Right quadrant which was 'coated with ZINGA ONLY. The cathodic reaction can be seen clearly from the Zinc Salts (white-grey) forming on the surface. This shows SUPERIOR cathodic protection. NO RUST

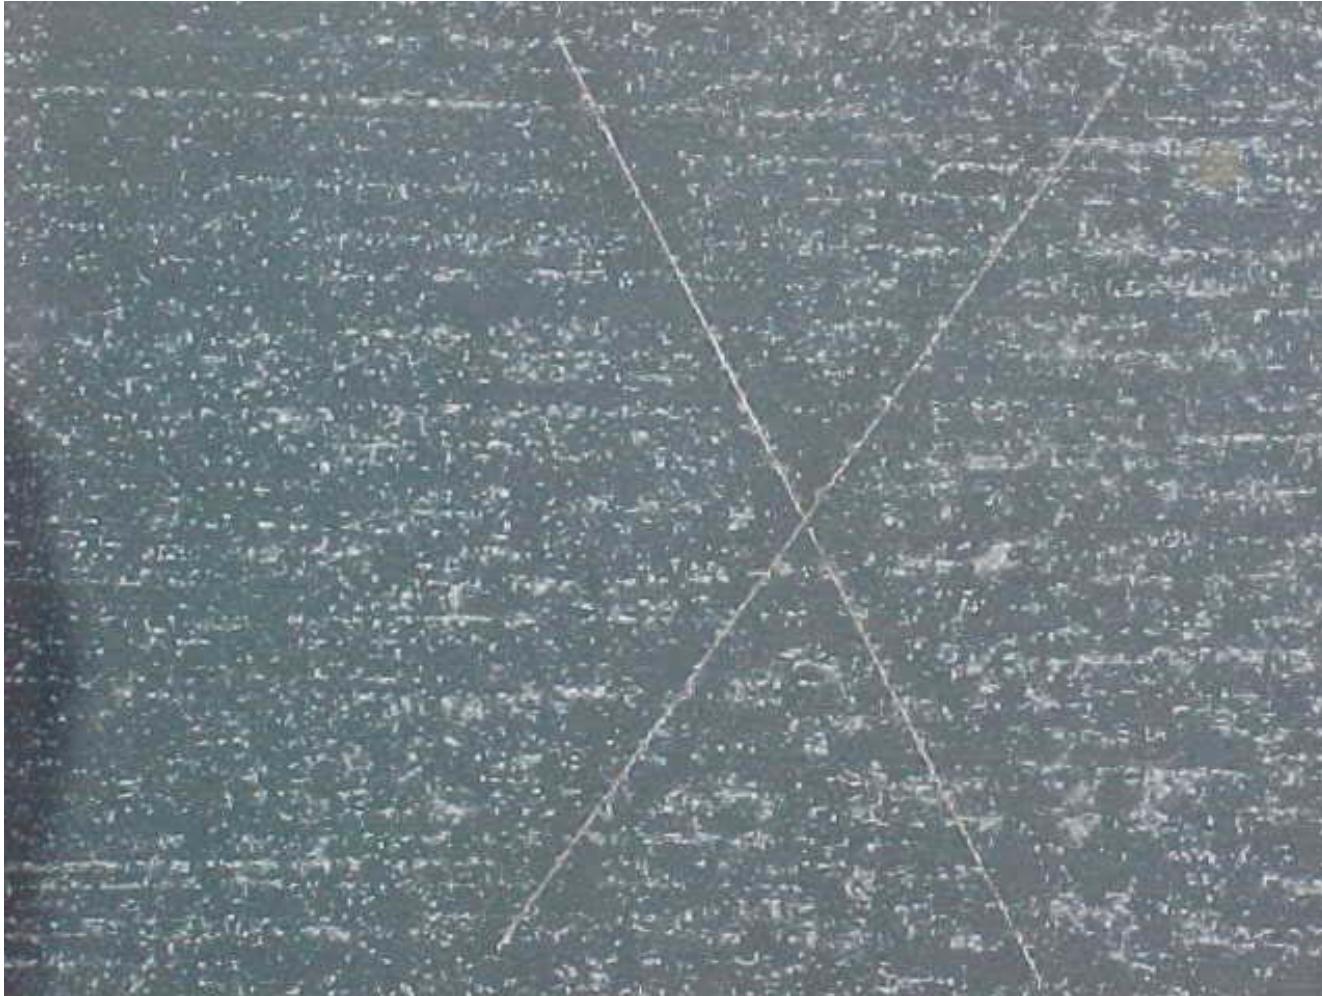
Quad Tests: This shows a **CLOSE UP** view of the lower right quadrant which was 'coated with **ZINGA ONLY**. The cathodic reaction can be seen clearly from the **Zinc Salts (white-grey)** forming on the surface. Note no rust at all even in the **CUT**. This is a outstanding picture of cathodic protection.

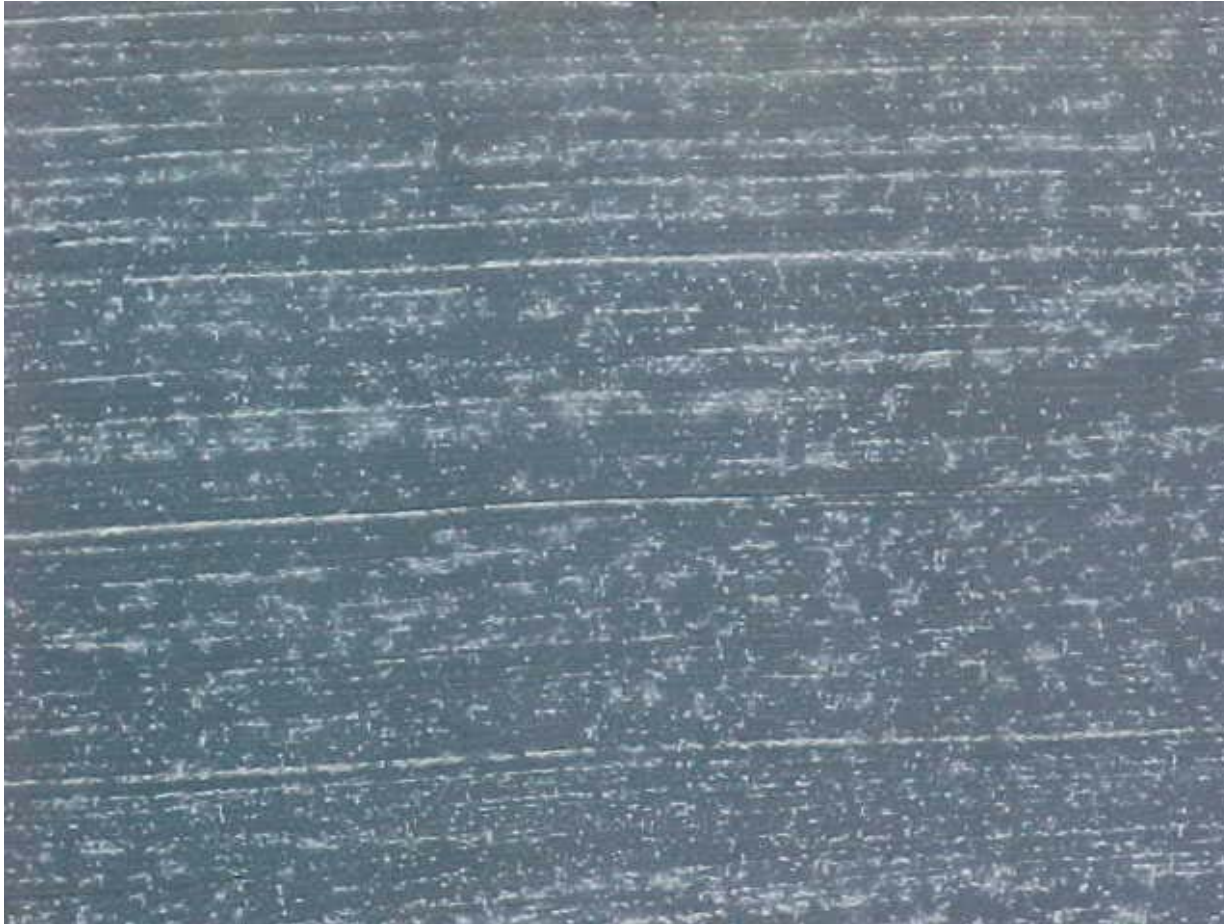
**Quad tests- This is a extreme close up of ZINGA ONLY
Quadrant showing absolutely NO RUST forming or coming
Through due to paint strokes. NO RUST**

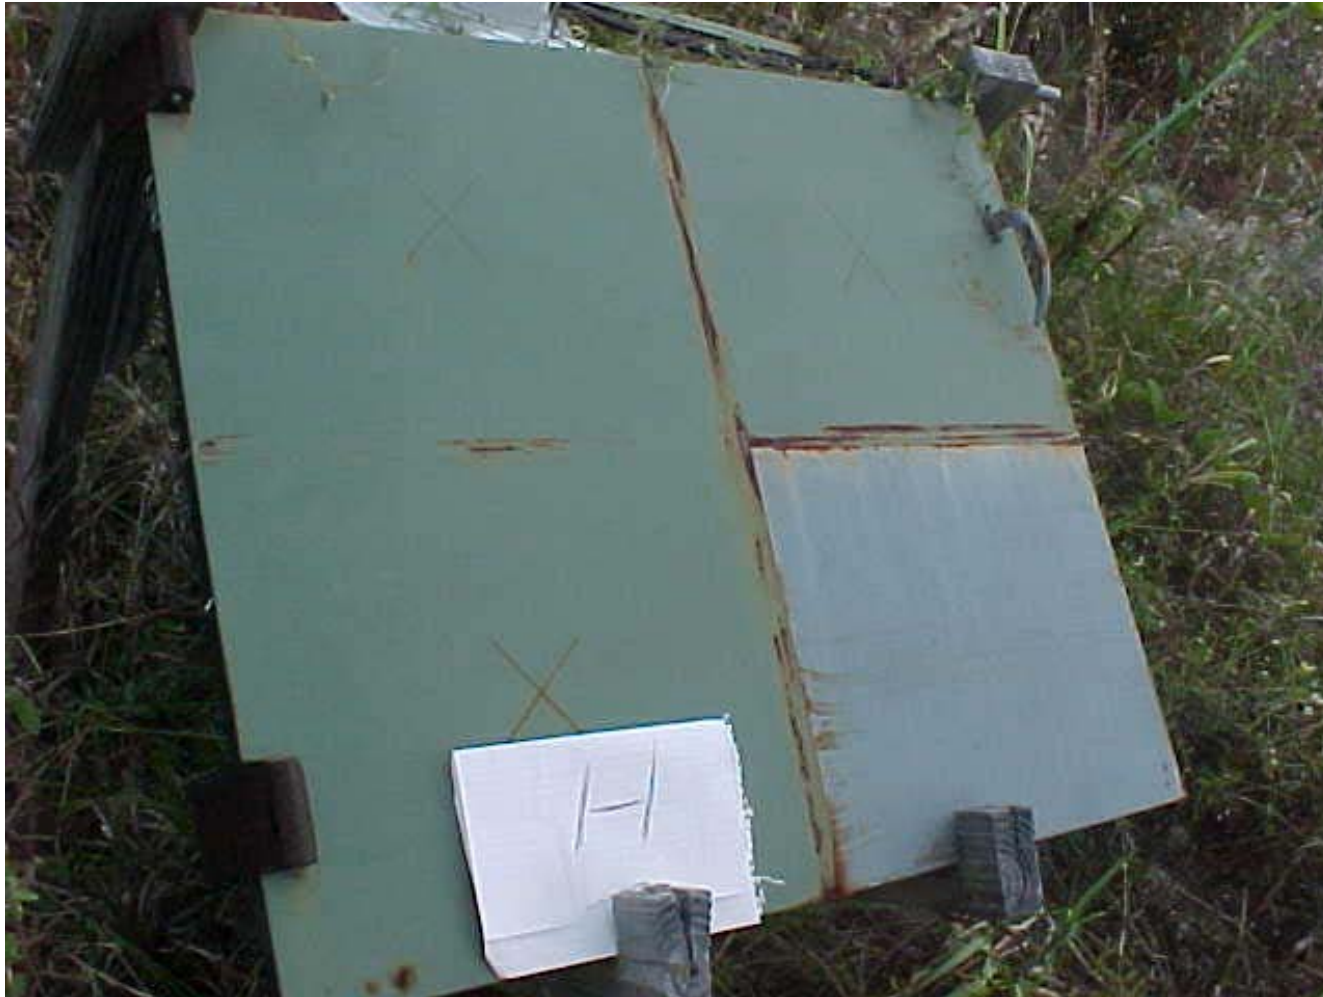
Quad Tests- This is ZINGA competitor, a Zinc rich paint A, at the US Army sea side test site sitting on a stand in front of ZINGA stand. Note that rust is coming through at all four quadrants.

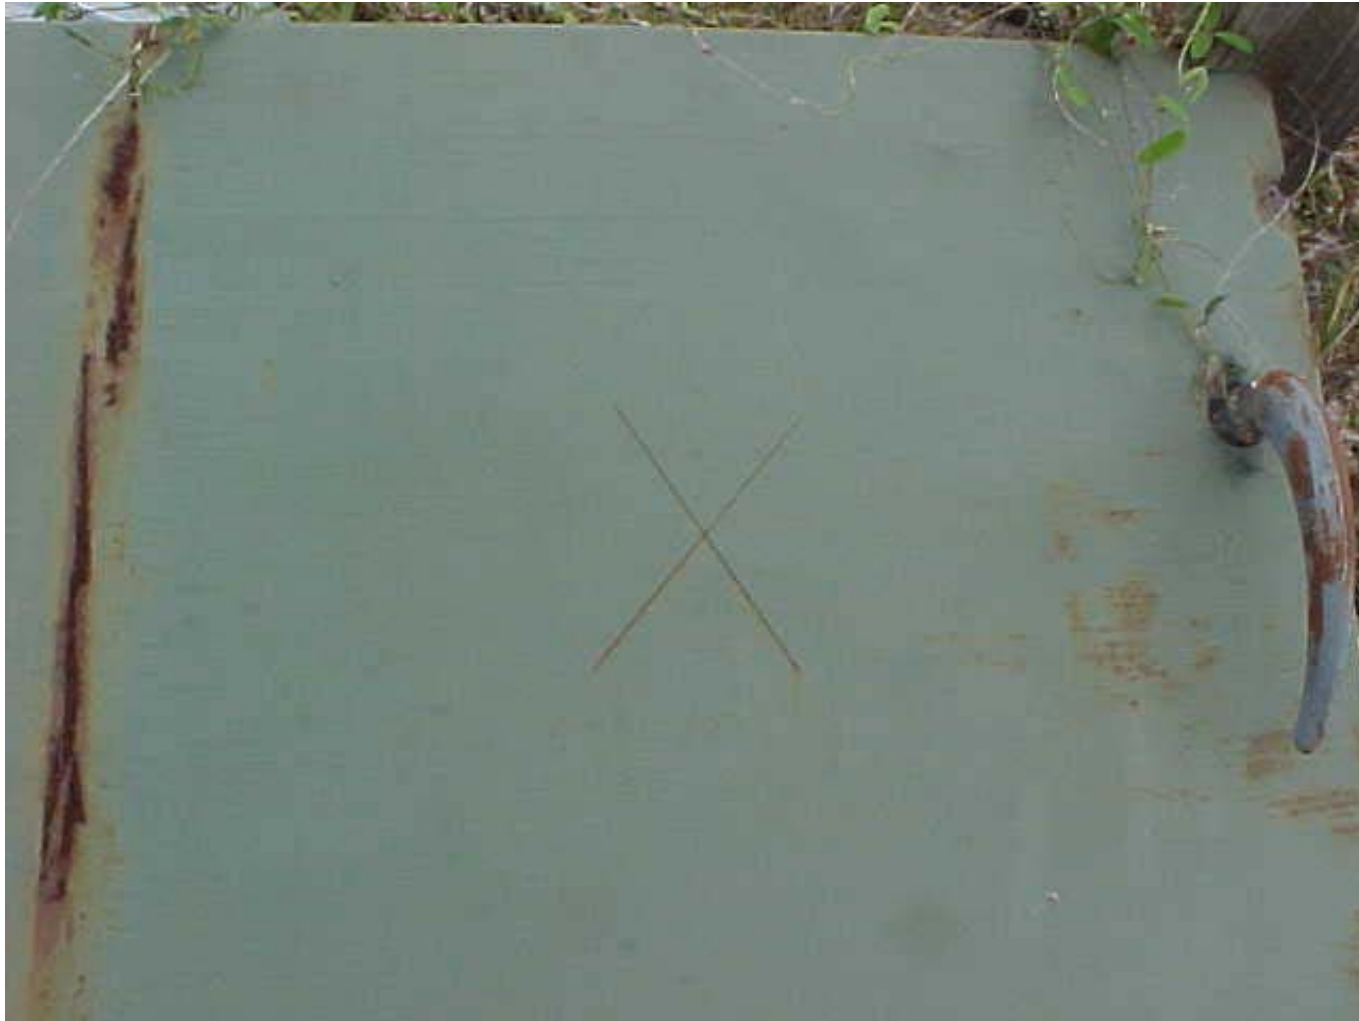
Quad Tests- This is upper right quadrant of Zinc rich paint A. Note that rust is coming through even with the paint A and a top coat. Clearly the Zinc rich paint has been ineffective In rust prevention after just 3 years in sea air environment.

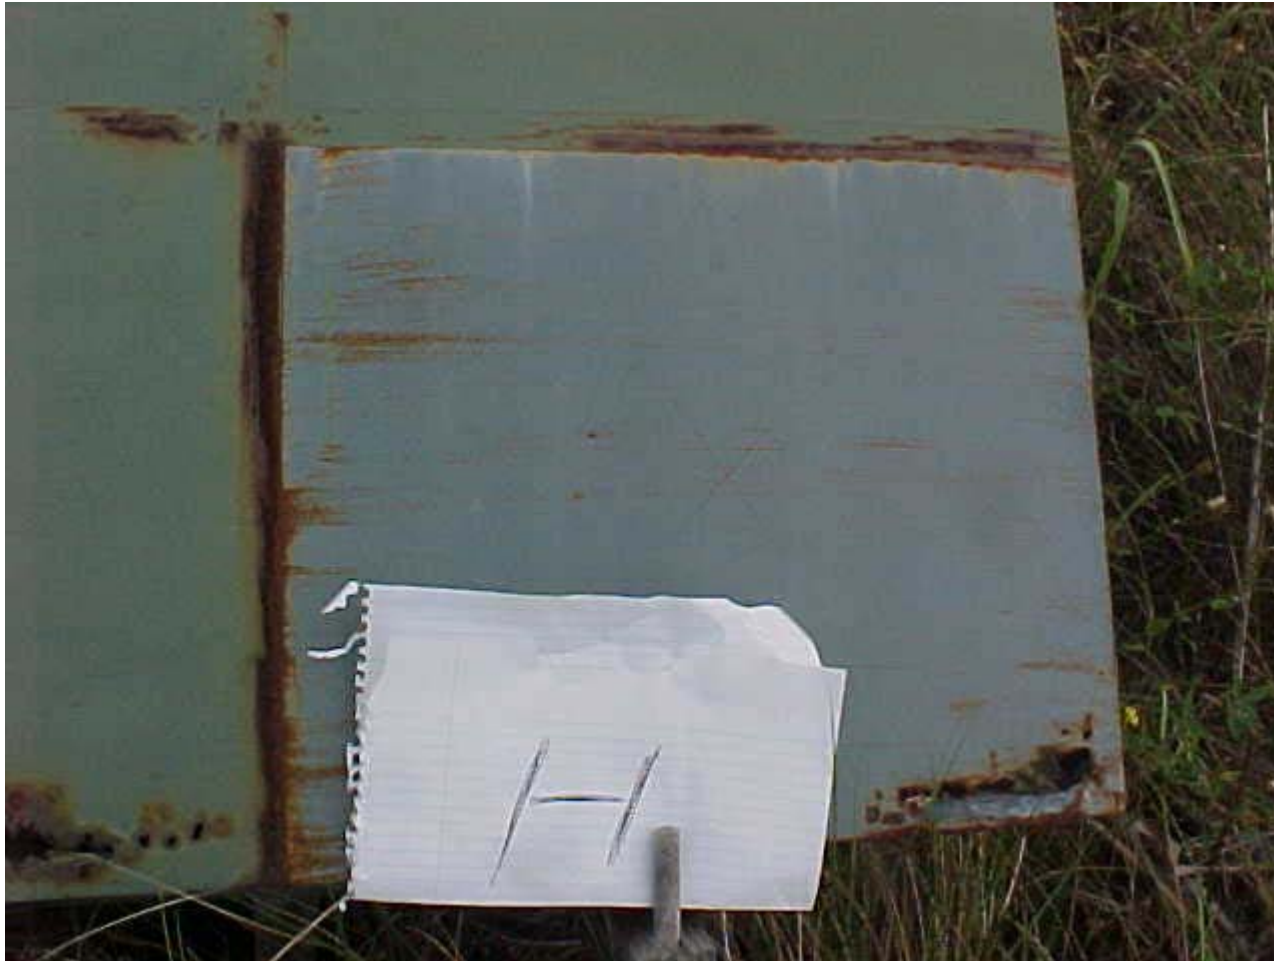
Quad Tests- This is lower right quadrant of Zinc rich paint A. This is Zinc rich paint A ONLY coating. Note that rust is coming through the paint strokes .Clearly the A has been Ineffective In rust prevention. Note also the lack of cathodic reaction, as very little Zinc salts can be seen. Extremely poor cathodic Protection.

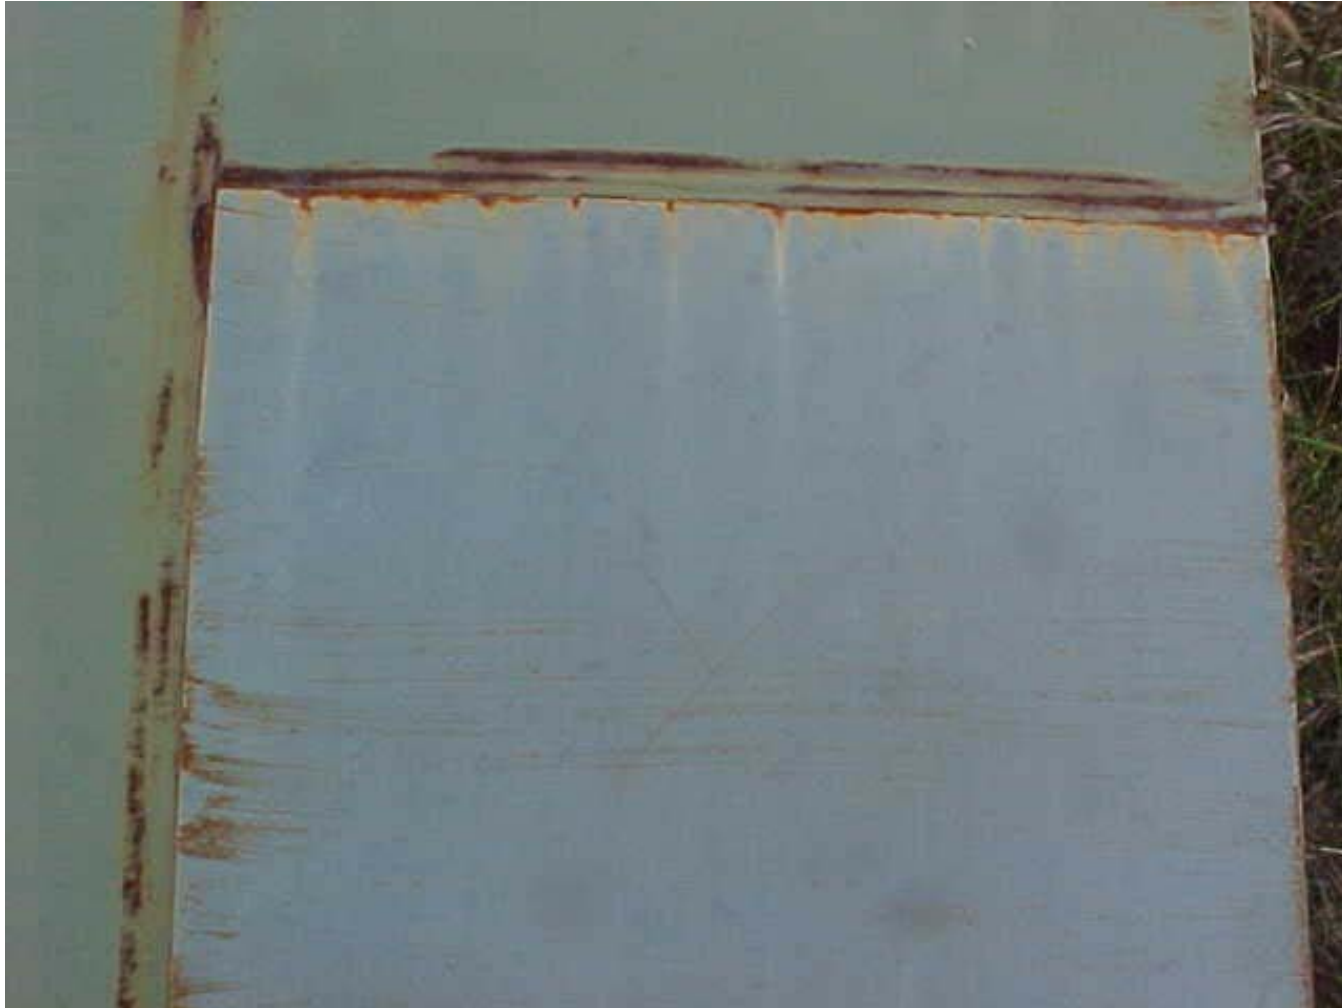
Quad Tests- This is lower right quadrant of Paint A. This is Zinc rich paint A ONLY coating. Note that rust is coming through the paint strokes Clearly A has been Ineffective In rust prevention.
