USAF Cape Canaveral Station, Florida

US Army Sea Side Corrosion Test Site

Report issued by MMI, Dick Yesensky, Nov.21st 2003

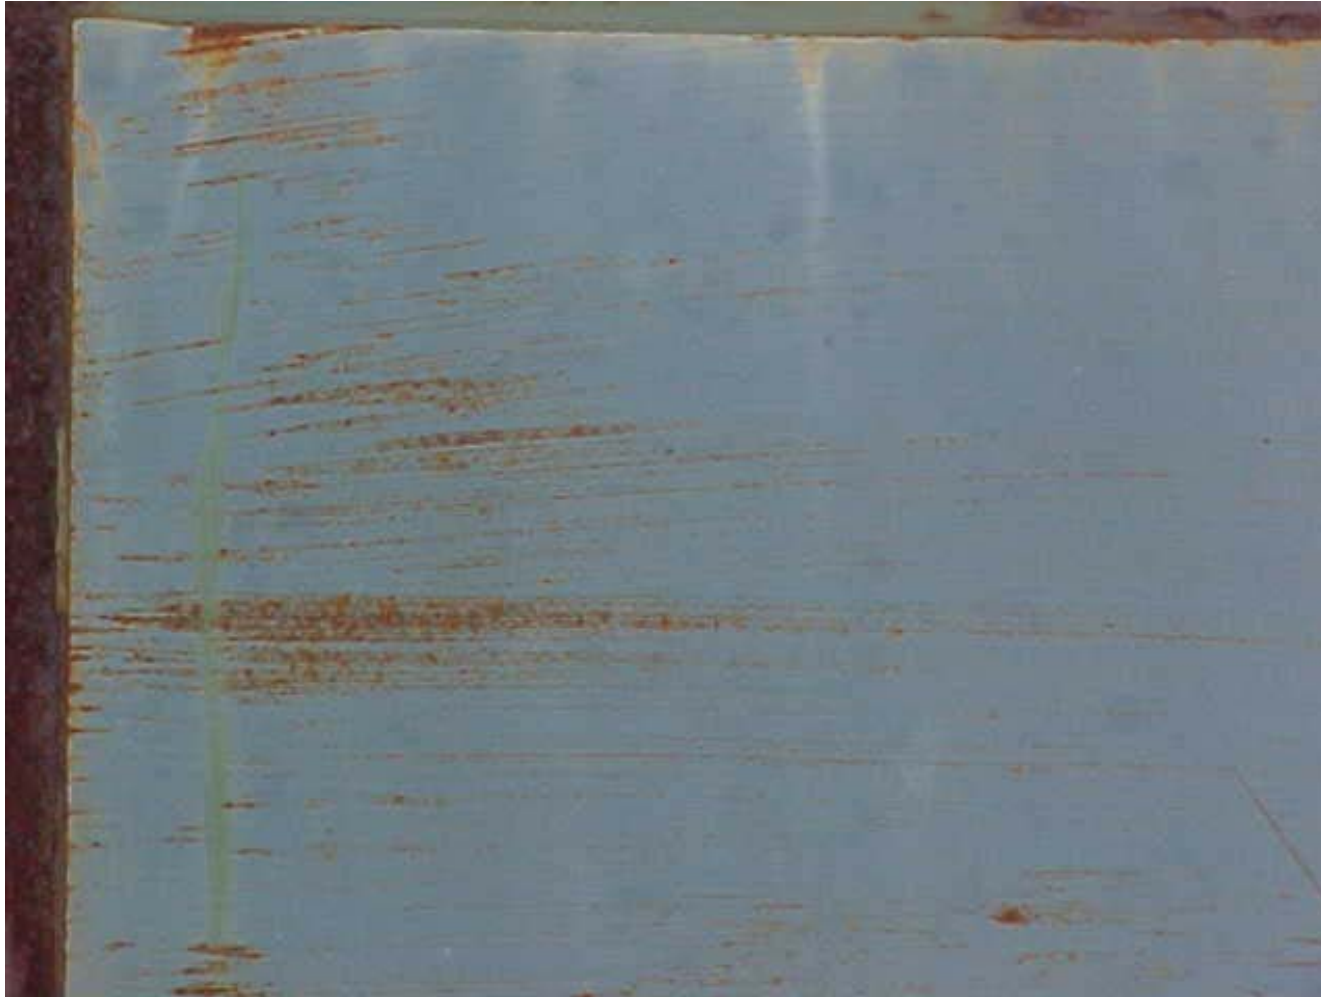
Quad Tests- This is close up of lower right quadrant of Paint A. This is Zinc rich paint A ONLY coating. Note that rust is coming through the paint strokes. Clearly A has been Ineffective In rust prevention. Note also the lack of cathodic reaction, as very little Zinc salts can be seen. Extremely poor cathodic Protection.
