**PACIFIC RIM CORROSION  
RESEARCH PROGRAM (PRCRP)**

**UPDATE OF ZINGA DOORS  
EXPOSED AT KENNEDY SPACE  
CENTER**

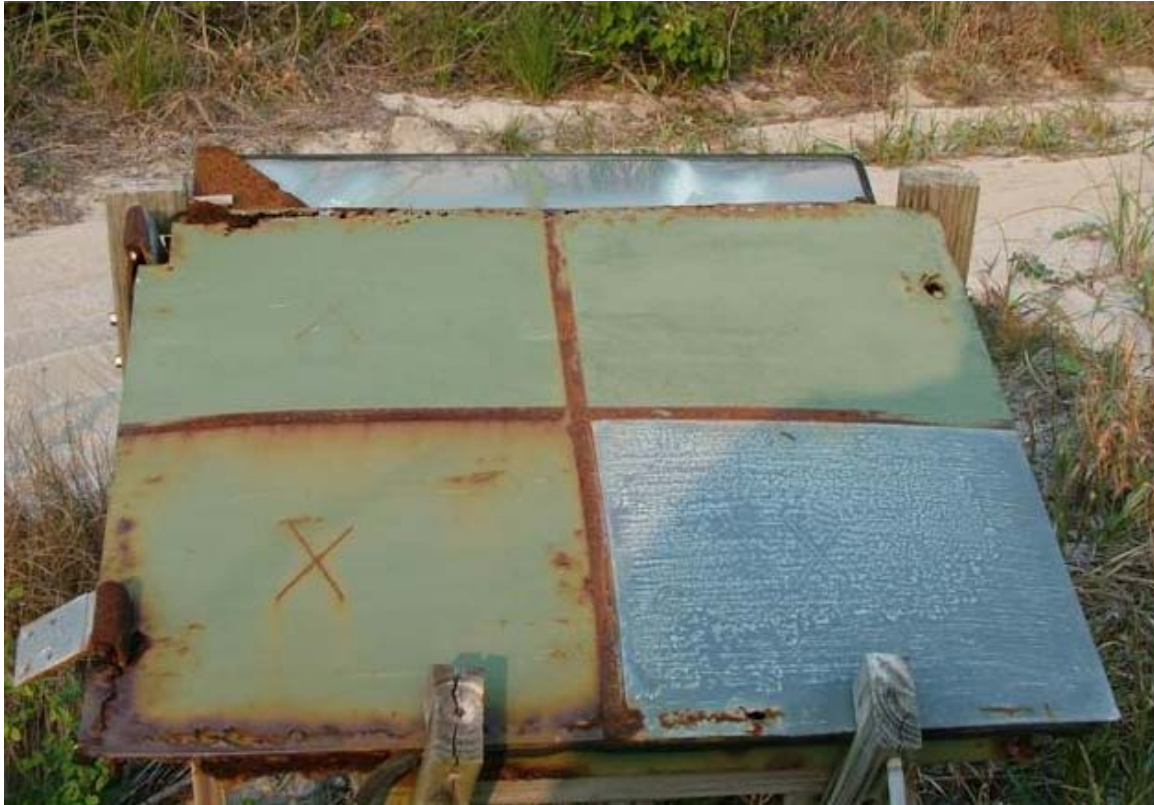
**Figure 2. 5-Ton Truck Door at KSC.**

The door was split into quadrants, for evaluation of four (4) coating system variations on one door. There were (from top left, going clockwise): Zinga/Epoxy/CARC, Zinga/CARC, Zinga and Epoxy/CARC (control).

Figure 2 shows that after four (4) years of exposure there is less corrosive attack of the test areas as well as in the scribes. For the Epoxy/CARC section, stage 2 corrosion was observed over 5% of the bold surface (excluding the edges as well as the pre-existing areas of metal loss due to corrosion). The only other area to exhibit stage 1 corrosion was the Zinga/Epoxy/CARC area, which has one initiation site. The Zinga area has stage 1 zinc corrosion, but no evidence of steel substrate corrosion on the bold surface.

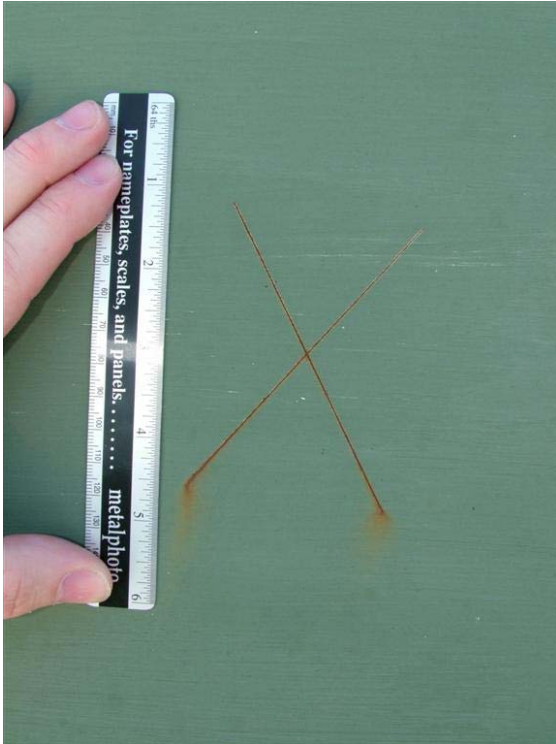
Figure 3 shows that the scribed areas of all sections except Zinga only have scribe corrosion. The corrosion products are heaviest in the Epoxy/CARC system scribes. This

system had a measurable cutback of up to 1/8-inch (3.2-mm). The other scribes did not have a measurable cutback. However, it was noted that the corrosion products in the Zinga/Epoxy/CARC scribes did appear heavier than the Zinga/CARC scribes. This may be an artifact of the porous nature of the CARC topcoat, which may provide a larger effective contact area between the steel exposed within the scribe and the zinc-rich coating, when moisture is present.
