17/02/2022  
Rev.1  
Test Report

## Cyclical ageing test of HDG 120 $\mu\text{m}$ + ZINGA 150 $\mu\text{m}$

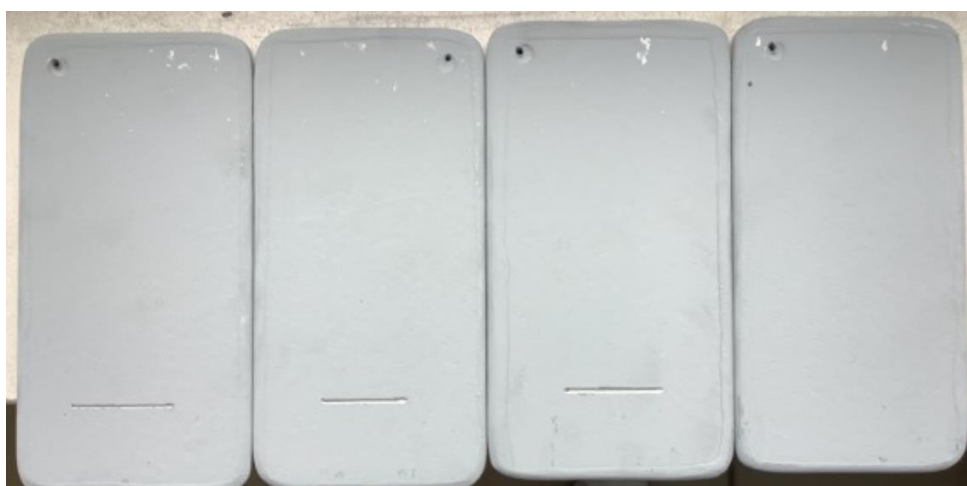
Figure 2. From left to right, Panel 11, 12, 14 and 15 before cyclical assessment

0 hours			
	System	Total DFT (µm)	Observations
Test panel 11	HDG + ZINGA	260	2 mm scribe was applied
Test panel 12	HDG + ZINGA	277	2 mm scribe was applied
Test panel 14	HDG + ZINGA	275	2 mm scribe was applied
Test panel 15	HDG + ZINGA	275	No scribe is applied

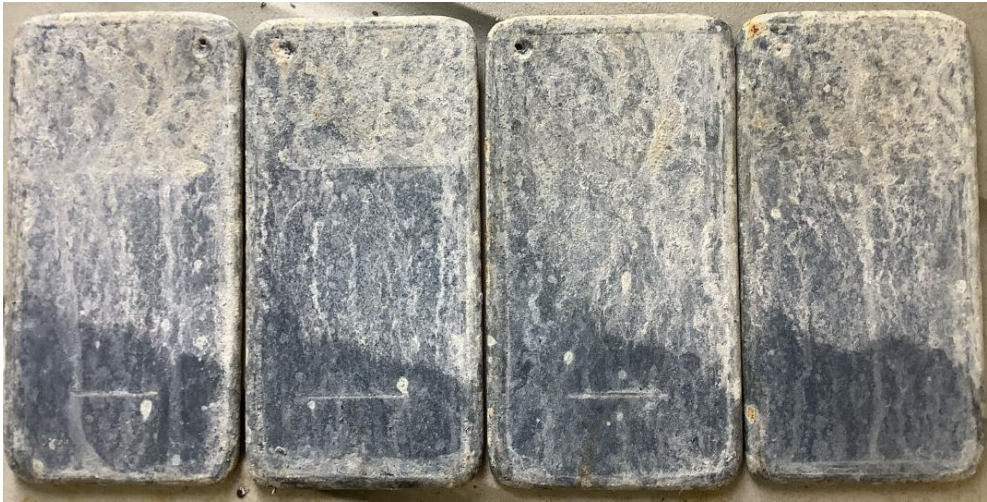
Figure 3. From left to right, Panel 11, 12, 14 and 15 at 2688 hours of cyclical testing (Requirement for C5 Very High)

2688 hours			
	System	Total DFT (µm)	Observations
Test panel 11	HDG + ZINGA	260	No observations
Test panel 12	HDG + ZINGA	277	No observations
Test panel 14	HDG + ZINGA	275	No observations
Test panel 15	HDG + ZINGA	275	No observations

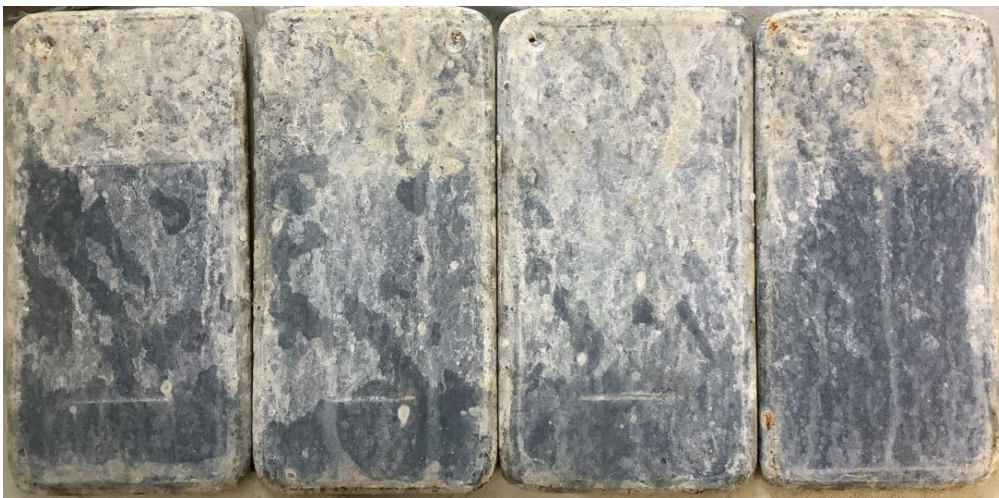
Figure 4. From left to right, Panel 11, 12, 14 and 15 at 4200 hours of cyclical testing (Requirement for CX)

<b>System</b>	<b>Total DFT (µm)</b>	<b>Observations</b>
<b>Test panel 11</b>	HDG + ZINGA	260	No observations
<b>Test panel 12</b>	HDG + ZINGA	277	No observations
<b>Test panel 14</b>	HDG + ZINGA	275	No observations
<b>Test panel 15</b>	HDG + ZINGA	275	No observations

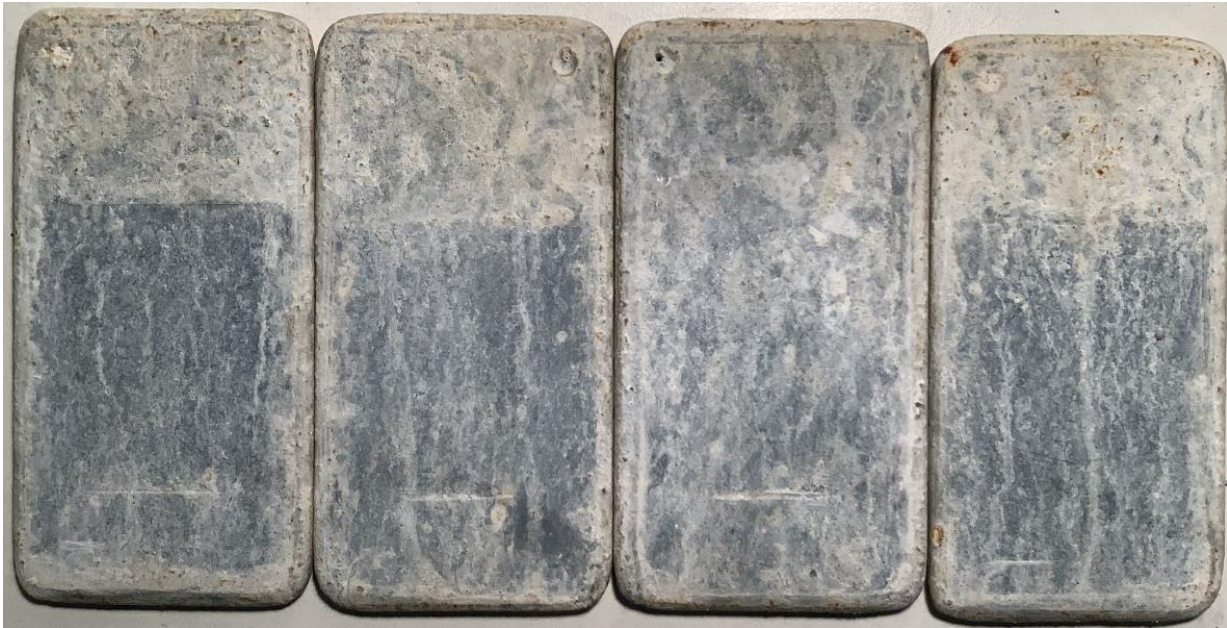
Figure 5. From left to right, Panel 11, 12, 14 and 15 at 7200 hours of cyclical testing

<b>System</b>	<b>Total DFT (µm)</b>	<b>Observations</b>
<b>Test panel 11</b>	HDG + ZINGA	260	No observations
<b>Test panel 12</b>	HDG + ZINGA	277	No observations
<b>Test panel 14</b>	HDG + ZINGA	275	No observations
<b>Test panel 15</b>	HDG + ZINGA	275	No observations

The system protects the steel from corroding up to 7200 hours of cyclical testing and the test is still pending. Moreover, there is no sign of any defect after 7200 hours. Even in the scribe that has been made, no corrosion occurs. Due to the electronegativity of HDG and ZINGA, the steel in the scribe is protected. It seems HDG and ZINGA have a very good compatibility. Let's see if we reach 8400 hours (double the requirement of CX with life expectancy 15-25 years) without corrosion.
