**13/03/2023**

## **Test Report**

### Cyclical ageing test of HDG 120 $\mu$ m + ZINGA 150 $\mu$ m – Rev.2

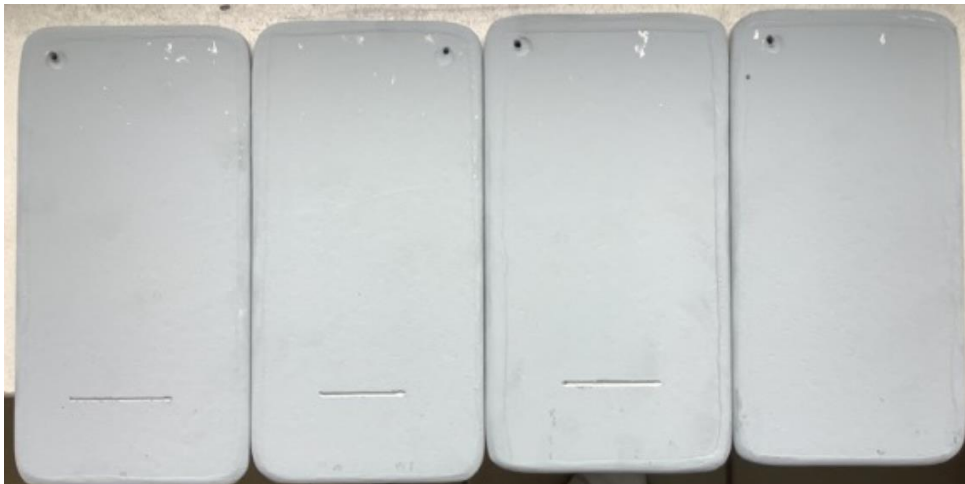
0 hours			
	System	Total DFT (µm)	Observations
Test panel 11	HDG + ZINGA	260	2 mm scribe was applied
Test panel 12	HDG + ZINGA	277	2 mm scribe was applied
Test panel 14	HDG + ZINGA	275	2 mm scribe was applied
Test panel 15	HDG + ZINGA	275	No scribe is applied

Figure 2. From left to right, Panel 11, 12, 14 and 15 before cyclical assessment

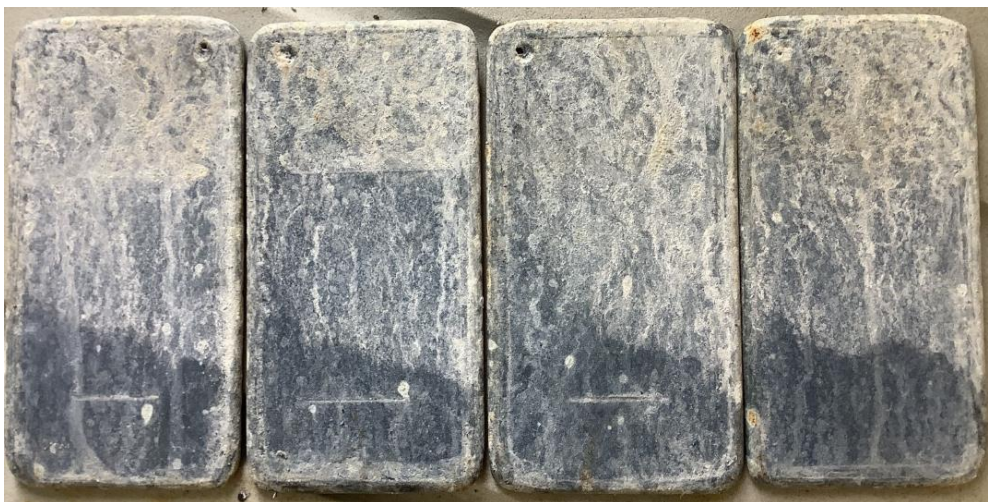
2688 hours			
	System	Total DFT (µm)	Observations
Test panel 11	HDG + ZINGA	260	No observations
Test panel 12	HDG + ZINGA	277	No observations
Test panel 14	HDG + ZINGA	275	No observations
Test panel 15	HDG + ZINGA	275	No observations

Figure 3. From left to right, Panel 11, 12, 14 and 15 at 2688 hours of cyclical testing (Requirement for C5 Very High)

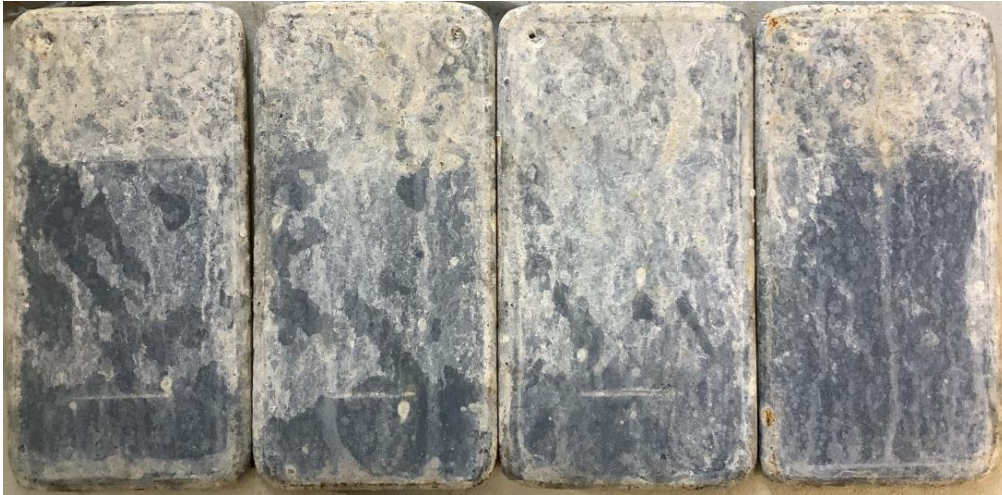
<b>System</b>	<b>Total DFT (µm)</b>	<b>Observations</b>
<b>Test panel 11</b>	HDG + ZINGA	260	No observations
<b>Test panel 12</b>	HDG + ZINGA	277	No observations
<b>Test panel 14</b>	HDG + ZINGA	275	No observations
<b>Test panel 15</b>	HDG + ZINGA	275	No observations

Figure 4. From left to right, Panel 11, 12, 14 and 15 at 4200 hours of cyclical testing (Requirement for CX)

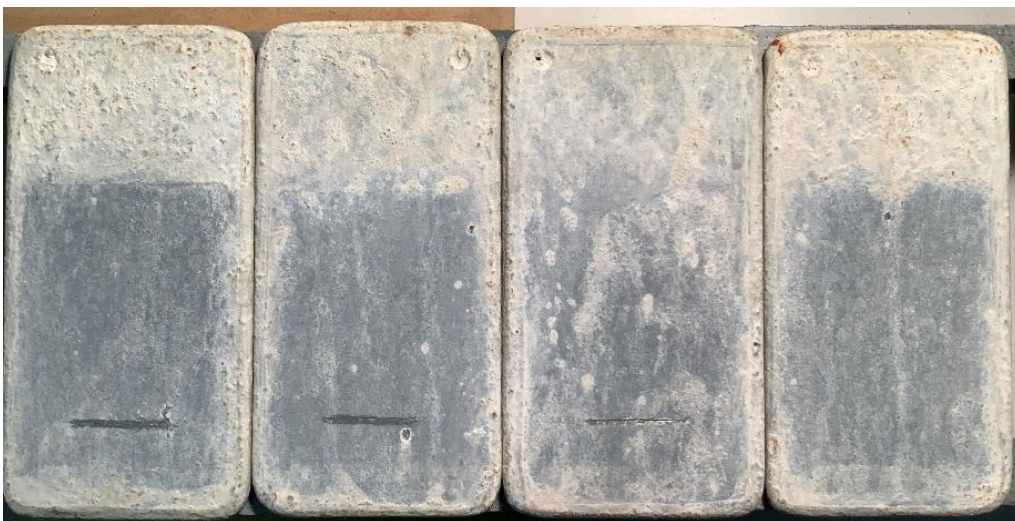
<b>System</b>	<b>Total DFT (µm)</b>	<b>Observations</b>
<b>Test panel 11</b>	HDG + ZINGA	260	No observations
<b>Test panel 12</b>	HDG + ZINGA	277	No observations
<b>Test panel 14</b>	HDG + ZINGA	275	No observations
<b>Test panel 15</b>	HDG + ZINGA	275	No observations

Figure 5. From left to right, Panel 11, 12, 14 and 15 at 8400 hours of cyclical testing

Method	Test panel 11	Test panel 12	Test panel 14	Test panel 15
DFT (µm)	260	277	275	275
ISO 4628-2 Blistering	0 (S0)	0 (S0)	0 (S0)	0 (S0)
ISO 4628-3 Rusting	Ri 0	Ri 0	Ri 0	Ri 0
ISO 4628-4 Cracking	0 (S0)	0 (S0)	0 (S0)	0 (S0)
ISO 4628-5 Flaking	0 (S0)	0 (S0)	0 (S0)	0 (S0)
Corrosion from scribe (mm)	0,0	0,0	0,0	NA

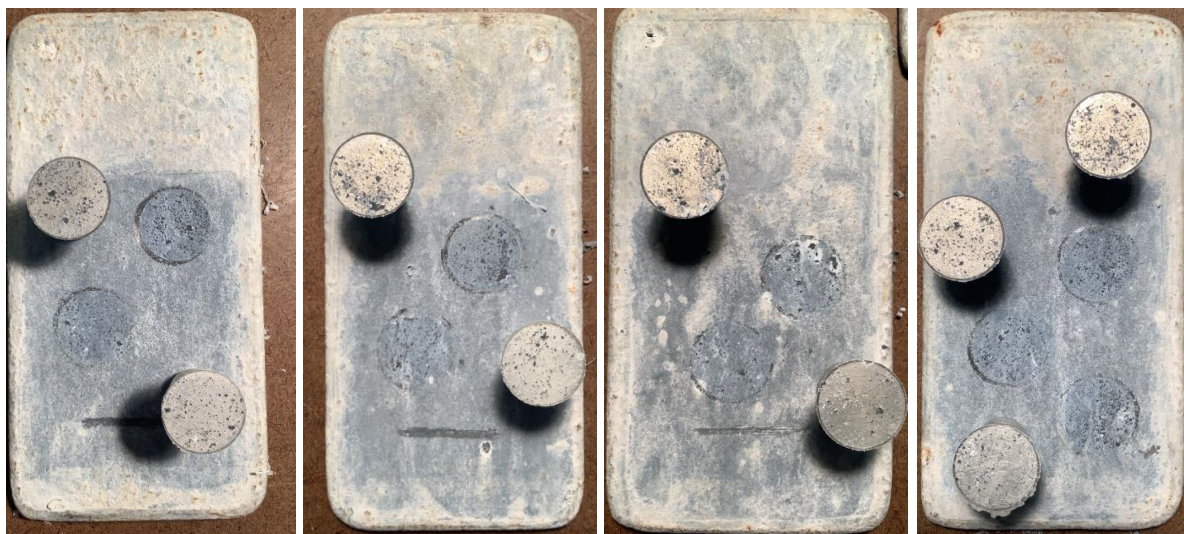
Method		Test panel 11		Test panel 12		Test panel 14		Test panel 15		
ISO 4624 method B Pull Off	*DFT (µm)	297	313	345	347	325	318	309	329	320
	Value (MPa)	6.6	5.4	5.4	6.4	5.4	6.7	7.0	5.4	4.5
	Brake	90% B/Y	90% B/Y	90% B/Y	90% B/Y	90% B/Y	90% B/Y	90% B/Y	90% B/Y	90% B/Y
Comments:		Glue failure		Glue failure		Glue failure		Glue failure

\* DFT's are higher than prior testing due to the formation of zinc corrosion products like carbonates, chlorides and hydroxides

Figure 6. From left to right, Panel 11, 12, 14 and 15 after adhesion testing.

It can be observed that all but one pull off values are above 5 MPa even though we have mostly an adhesive glue failure. The coating system beneath the dollies remain intact after the adhesion test as DFT measured show similar values as the DFT measurements prior testing.
