# ZINGA ON REBARS

## THE PROTECTION OF REBARS WITH ZINGA

## TEST REPORTS ON ZINGANISED REBARS

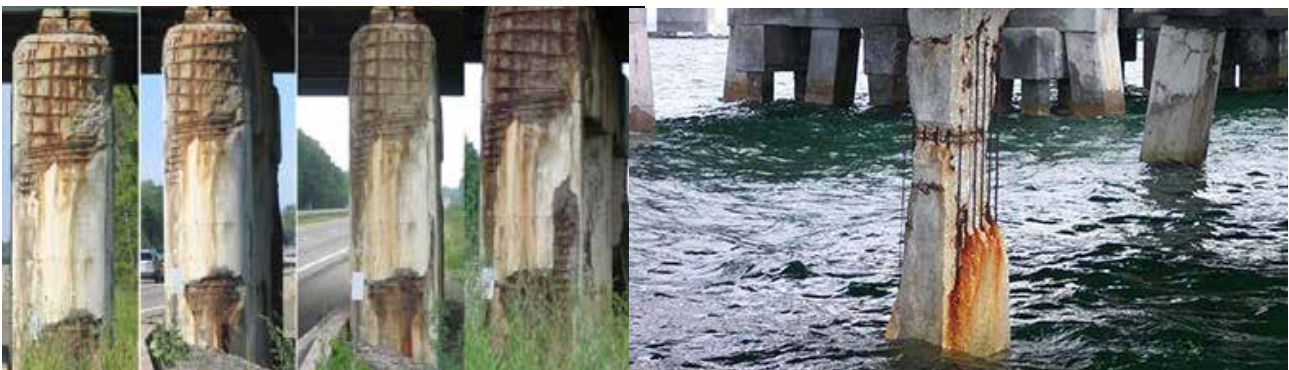
Passivation can be destroyed due to a reduction in alkalinity. This can have various causes :

- infiltration of atmospheric carbon dioxide (CO<sub>2</sub>) (carbonation)
- infiltration of sulphur dioxide (SO<sub>2</sub>) in industrial climates
- infiltration of aggressive chloride ions in marine environments
- infiltration of de-icing salts sprayed on the concrete surface of roads in winter

The rust can form up to 2 times the volume of the initial steel and can cause cracking of the concrete or even the complete destruction of it.

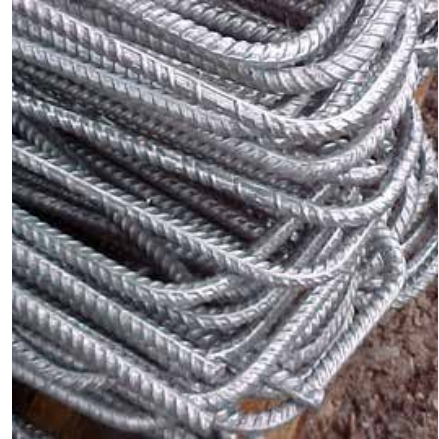
HDG Rebar

The second solution was hot-dip galvanisation, but this is still far from perfect. Cracks caused by the bending of the rebars, can easily destroy the galvanising layer. Another problem is that hot-dip galvanised rebars do not provide enough adhesion for the concrete. Moreover, the rebars need to be galvanised in a specialised workshop, equipped with a galvanising bath, which means that the rebars have to be restricted in size. This will cost time and money due to the distance and the transport to this galvanising workshop, which can be very expensive in some parts of the world.

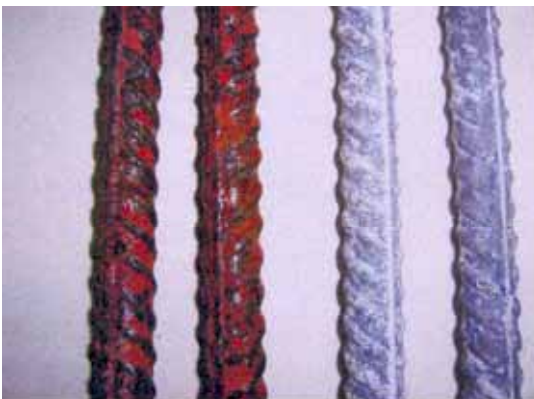
The zinganised rebars passed the 500 hours salt spray test without formation of rust, peeling or blistering, not even in places where the coating was mechanically damaged. The rebars that were not zinganised were heavily corroded.

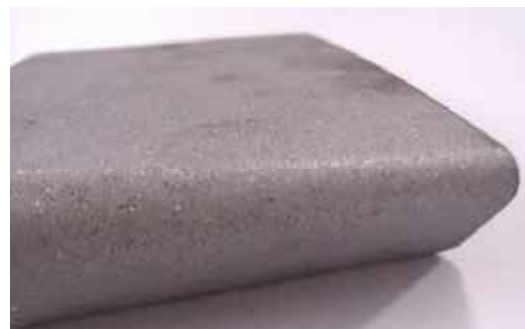
ZINGA has been applied at a layer thickness of 60 µm DFT on test panels and bent by a mandrel tester at 23°C and 50% RV. The diameter of the mandrels are 32 mm, 25 mm, 20 mm, 16 mm, 13 mm, 12 mm, 10 mm, 8 mm, 6 mm, 5 mm, 4 mm, 3 mm and 2 mm.

Immediately after bending, the coating has been examined under good illumination with normal corrected vision.

ZINGA showed no cracks when bending on a cylindrical mandrel with a diameter of 12 mm.

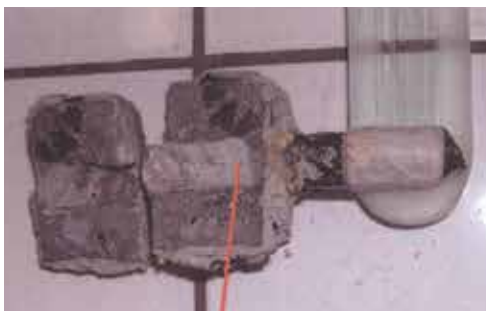
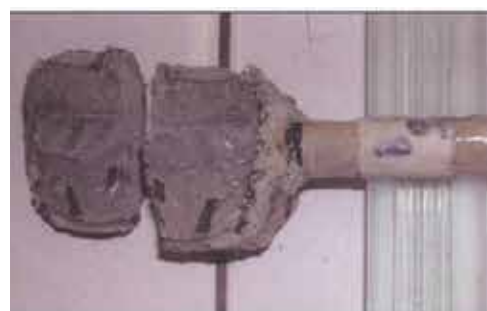
A custom test was designed to test the adhesion of (zinganised) rebars to the concrete. A rebar coated with ZINGA, an untreated and a sandblasted rebar were imbedded in concrete.

The rebars were aged using  $\text{SO}_2$  (Kesternich).

The concrete was cleaved, in order to set free the steel reinforcement.

It is clearly more difficult to cleave the rebar bloc containing the steel rod protected with ZINGA. The adherence of the concrete to the Zinganised rod is better. The actual cleavage happens in the concrete (in contrast to the other two rebars, which cleaved neatly between steel and concrete), which indicates a strong adherence.

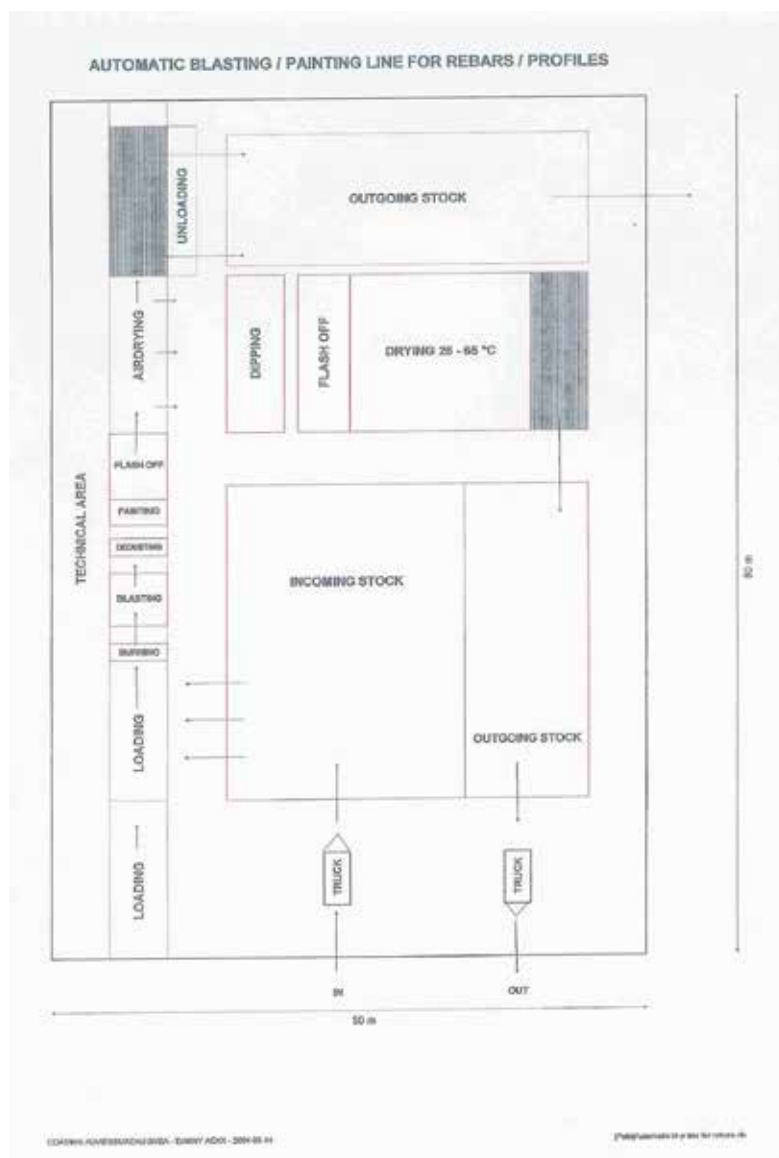
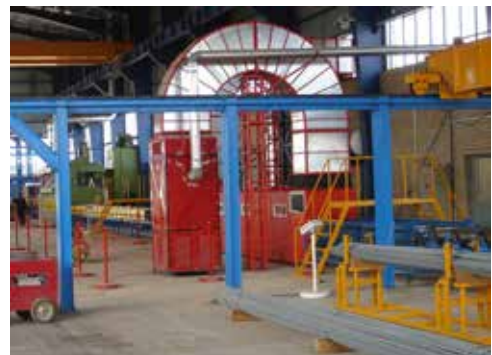
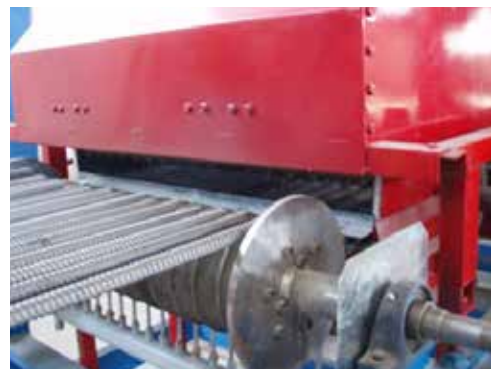
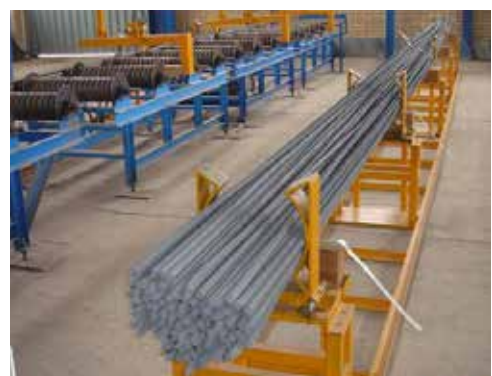
In the period 2005-2010 large quantities of Zinganised rebars have been produced at an automatic rebar coating installation in Iran by our distributor.

1. Incoming uncoated rebars are stocked above the feeding line, up to a quantity of 50 tons.
2. All rebars are manually handled onto an automatic side conveyor. Up to 16 rebars per charge.

3. The side loader is automatically transferred to the treatment line. The 16 rebars are lifted and positioned in the treatment line.
4. The rebars are then heated. The heat will loose the mill scale from the underlying steel. The surface temperature of the rebars mounts up to 60°C.

5. The rebars automatically enter the wheel blast machine. Automatic (electrically driven) wheel blasters are grit-blasting the rebars to cleanliness degree SA 2,5 and roughness degree 30 to 40 µm Rz. The surface temperature of the rebars is still too high after blasting.

6. The rebars are then pushed through brushes in order to remove the dust and grit, this is followed by dedusting with clean air.
7. The rebars automatically enter the temperature equalising area. In order to avoid temperature stresses in the steel, the inner and outer temperature of the rebars is equalised.

8. The rebars pass through an automatic spray booth in which two reciprocators are spraying the Zinga.
9. The rebars pass through a drying oven.
10. The rebars are transferred automatically to the end station for unloading.

11. The rebars are automatically unloaded and are manually bound together, so that they are ready for transport.
